### **AQUATIC ASSESSMENT**

# Aquatic baseline report for Ballivor wind farm, Co. Meath/Westmeath

Prepared by Triturus Environmental Ltd. for McCarthy Keville O'Sullivan Ltd.

**October 2021**

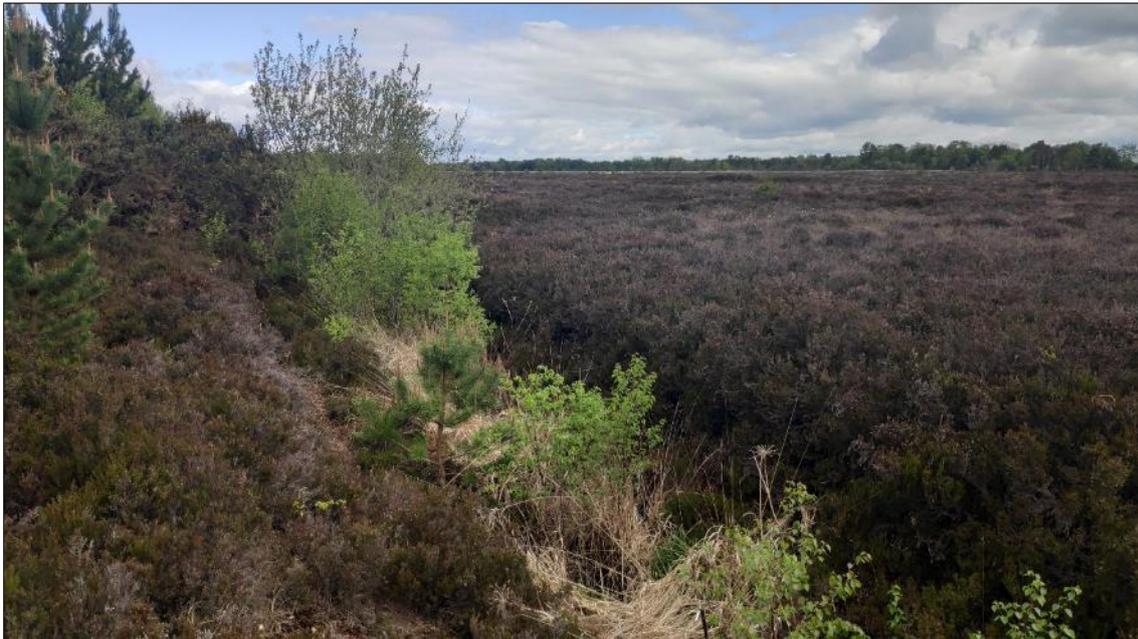
**Plate 4.1** Representative image of site A1 on the Cartenstown Stream, May 2021

Biological water quality, based on Q-sampling, was calculated as **Q2-3 (poor status) (Appendix B)**. However, it should be noted that, given the poor flows and heavily silted nature, this is a tentative Q-rating. No macro-invertebrate species of conservation value greater than 'least concern', according to national red lists, were recorded via Q-sampling.

The aquatic ecological evaluation of site A1 was of **local importance (lower value) (Table 4.1)**.

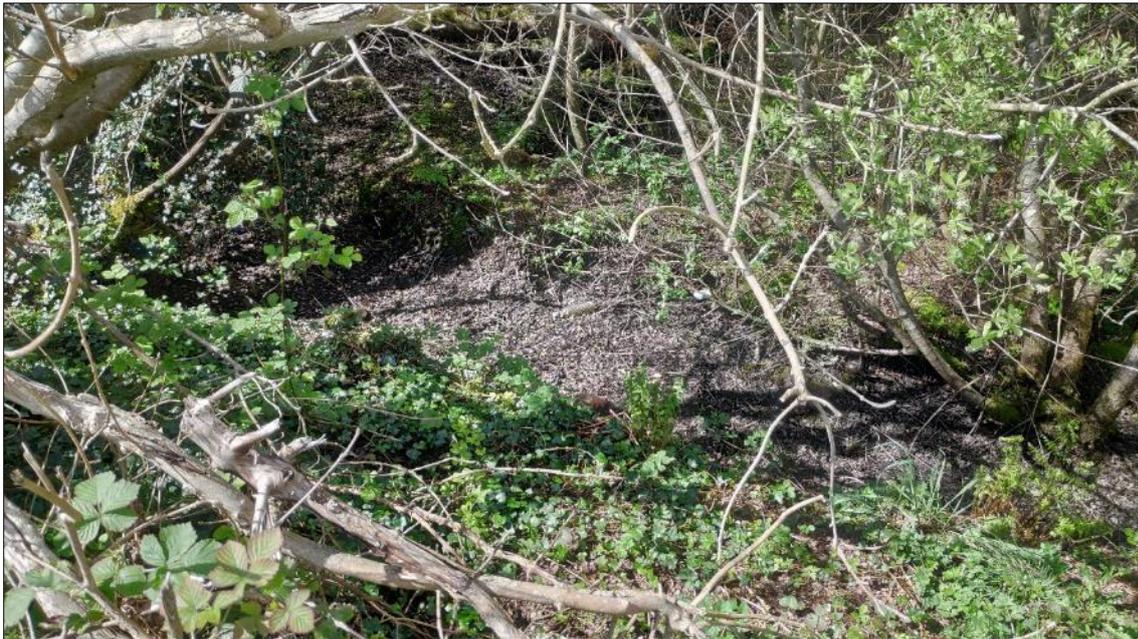
**Plate 4.2** Representative image of site A2 on the Stonestown River, May 2021 (channel 100% dry)

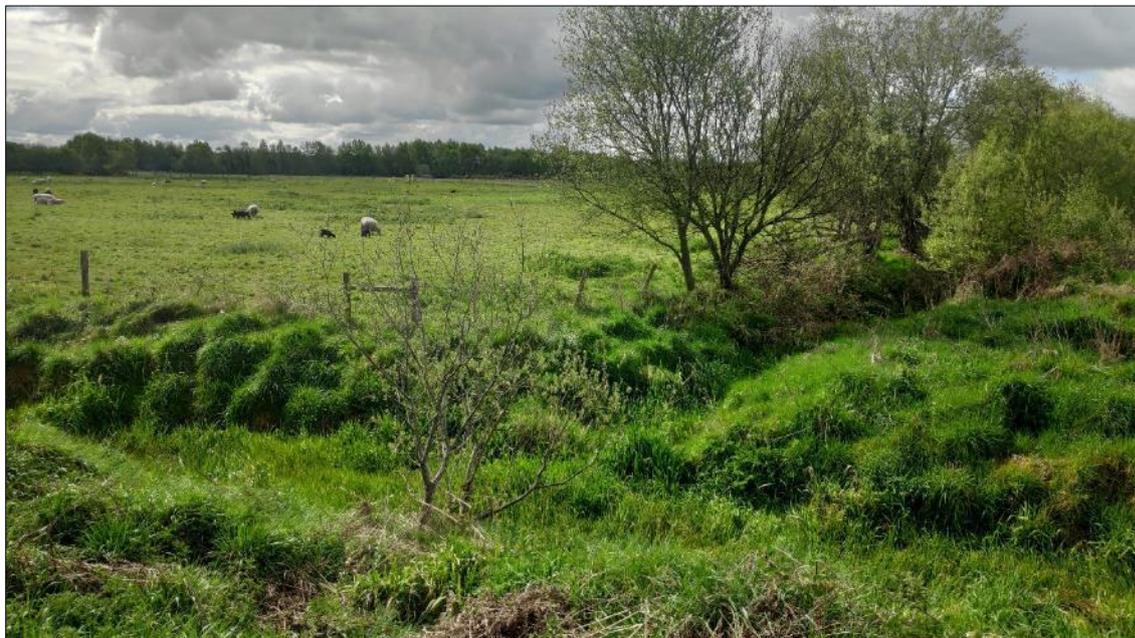
**Plate 4.3** Representative image of site A3 on the Ballinn Stream, May 2021 (stream is in background, with adjoining drainage channel in foreground)

Site A3 was located on the upper reaches of the Ballinn Stream (07B47) at a local road crossing north of the wind farm site boundary. The stream represented a 1.5-2m-wide peat drainage channel (FW4) that had been straightened and deepened historically, with bankfull heights of 2m-2.5m in a steep U-shaped channel. The channel had been excavated to a uniform depth of 0.6-0.7m and was heavily silted (peat deposition). Some fine to medium gravels were present underfoot but these were heavily bedded in silt. Peat staining was high. The stream adjoined another channel along the adjacent local road which featured greater depths to 0.8m in a 2m wide channel. The site was heavily covered with terrestrial and aquatic vegetation. Macrophytes recorded included occasional watercress (*Nasturtium officinale*) and common duckweed (*Lemna minuta*) with >90% cover of bentgrass (*Agrostis* sp.) instream, creating extensive floating mats. Reed canary grass (*Phalaris arundinacea*) was also present along the banks and instream. There was no open water present. Flow was very slow at the time of survey (even following rainfall). Upstream of the confluence, the Ballinn Stream was heavily shaded by riparian scrub with frequent downy birch and grey willow treelines. To the west, cutover bog (PB4) with high birch cover was present, with GA1 (sheep grazing) to the west and downstream of the road crossing (pipe culvert).

Biological water quality, based on Q-sampling, was calculated as **Q2-3 (poor status) (Appendix B)**. However, it should be noted that, given the poor flows and absence of faster flowing riffle and glide habitat heavily, this is a **tentative** Q-rating. No macro-invertebrate species of conservation value greater than 'least concern', according to national red lists, were recorded via Q-sampling.

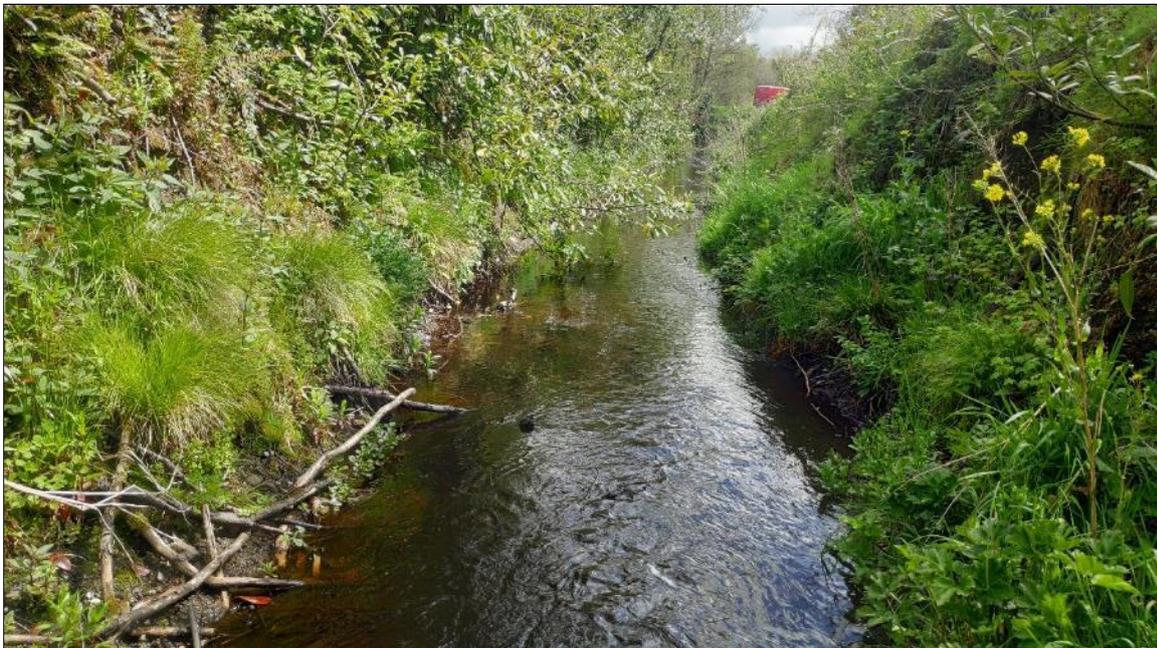
**Plate 4.4** Representative image of site A4 on the Bolandstown River, May 2021

Site A4 was located on the upper Bolandstown River (07B45) at a local road crossing. The river was a small lowland depositing watercourse (FW2) which had been historically straightened and deepened. Recent maintenance (bank clearance and excavation) was evident upstream of the bridge. The river averaged 2m wide and 0.1-0.2m deep in a deep V-shaped channel with 2-3m bankfull heights. The site predominantly featured shallow moderate flowing glide habitat with occasional riffle areas and even more occasional pools (max depth 0.4m). The water was heavily peat-stained at the time of survey (following recent rain) and the substrata were moderately to heavily silted with flocculent peat. The bed was dominated by soft sand (low compaction) with frequent silt deposits (some >15cm deep). Exposed gravels were rare but present (tailings of pools etc.) but these were compacted/bedded. Boulder and cobble were absent. Instream macrophytes were limited to emergent species given the high peat-staining with occasional watercress, brooklime (*Veronica beccabunga*) and water speedwell (*Veronica* sp.) along channel margins. Downstream of the bridge, the river was adjoined by improved pasture (GA1) and scrubby woodland dominated by willow, birch and occasional ash (*Fraxinus excelsior*) along the channel with frequent cherry laurel (*Prunus laurocerasus*). An area of clear-fell (WS5) was located adjacent to the channel upstream of the bridge (south bank).

Three-spined stickleback and *Lampetra* sp. were the only species recorded via electro-fishing (**Appendix A**). Site A4 had low nursery, spawning and holding value for salmonids given the poor thalweg and very high levels of siltation and none were recorded during electro-fishing. The channel was not considered of value to European eel given the absence of refugia such as cobble and boulder. The channel was however of some value to lamprey given pockets of fine silt with a high organic content up to 20cm deep adjoining areas with finer gravels (albeit degraded by silt). Low to moderate densities of lamprey were recorded at 2.8 per m<sup>2</sup> (5m<sup>2</sup> of habitat targeted and 14 ammocoetes captured). The site offered no suitability for white-clawed crayfish, given heavy siltation. Although no otter signs were recorded, there was some low foraging potential for the species.

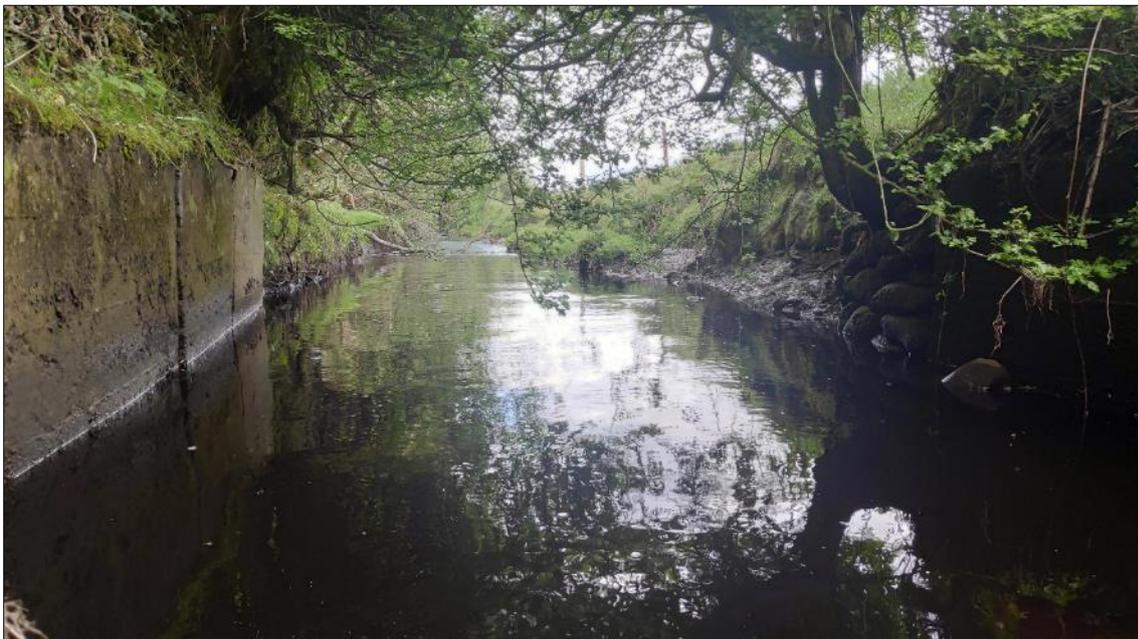
**Plate 4.5** Representative image of site A5 on the Cartenstown Stream, May 2021 (facing downstream from underneath road bridge)

and cobble with frequent boulder. Sand was frequent and sand/silt accumulations were present in channel margins and slacks. The bridge featured a concrete apron with harder substrata atop. Overall, siltation (peat derived) was moderate. Given high peat staining, there were no visible macrophytes or aquatic bryophytes. The stream flowed through improved pasture (GA1) with associated riparian treelines (WL2) and hedgerows of hawthorn (*Crataegus monoygna*), elder (*Sambucus nigra*), willow, privet (*Ligustrum vulgare*) and scrubby bramble understories.

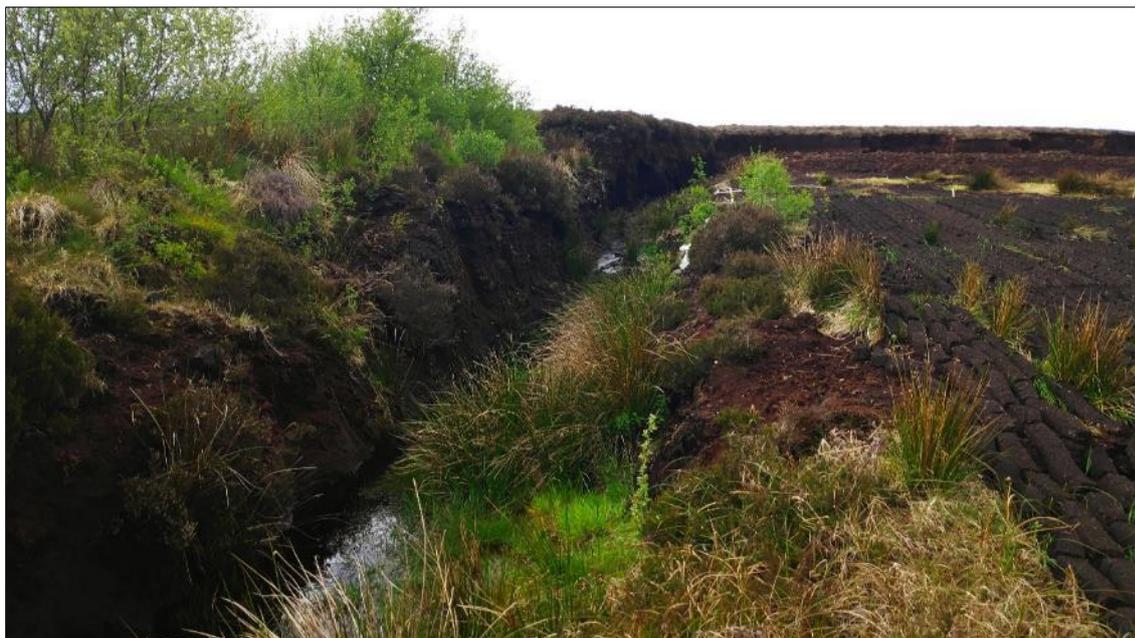
**Plate 4.6** Representative image of site A6 on the Woodtown West Stream, May 2021

Biological water quality, based on Q-sampling, was calculated as **Q3 (poor status) (Appendix B)**. However, it should be noted that, given the poor flows and absence of faster flowing riffle and glide habitat heavily, this is a tentative Q-rating. No macro-invertebrate species of conservation value greater than 'least concern', according to national red lists, were recorded via Q-sampling.

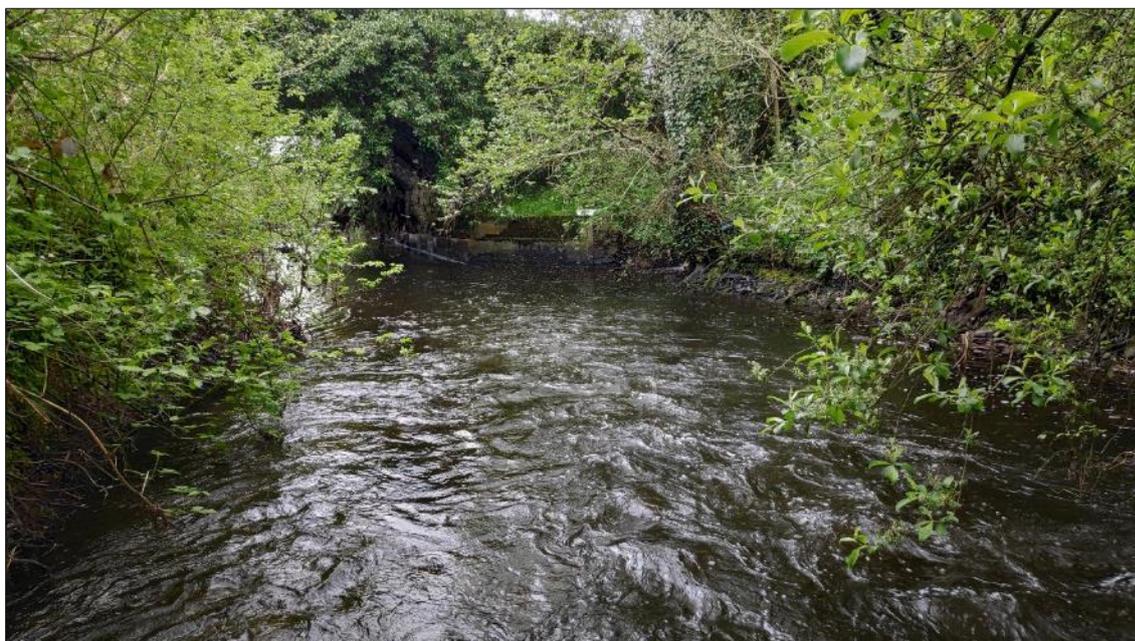
**Plate 4.7** Representative image of site A7 on the Stonyford River, May 2021 (facing downstream towards bridge)

Given the location of the Stonyford River within the River Boyne and River Blackwater SAC (002299), the aquatic ecological evaluation of site A7 was of **international importance**.

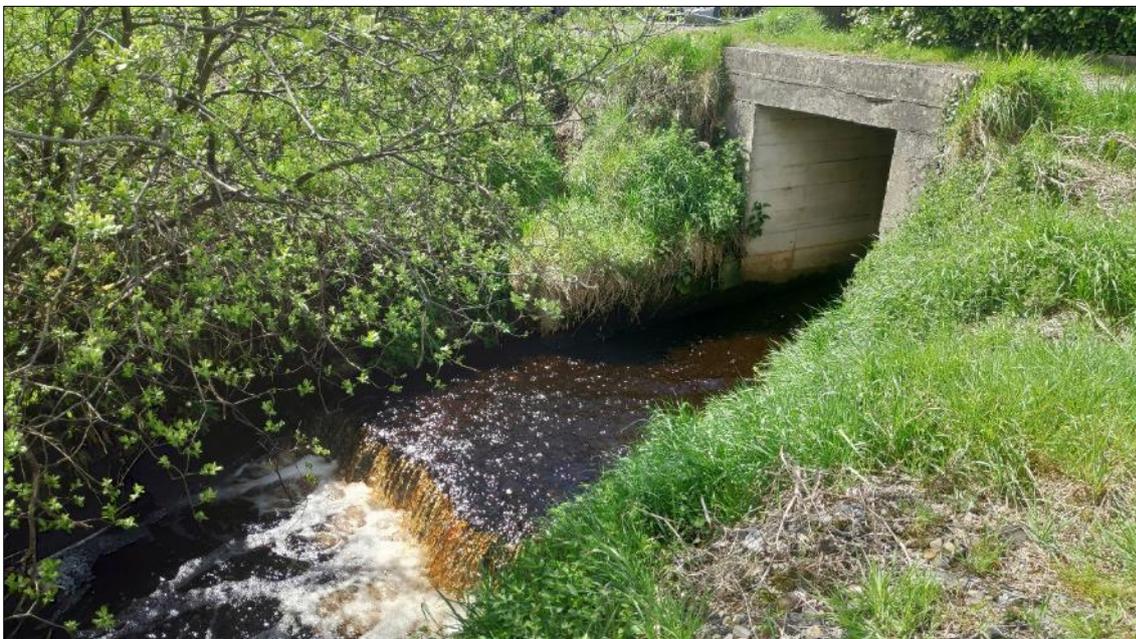
**Plate 4.8** Representative image of site A8 on the Carranstown Little River, May 2021

peat staining was very high at the time of survey. Silt accumulations were present and, despite having high fractions of sand, were invariably soft (uncompacted). Glide habitat dominated with only occasional pool and even more occasional riffle areas. Instream macrophytes were absent given the peat-staining but the semi-aquatic moss *Brachythecium rivulare* was present on the lip of the bridge apron (2ft fall, barrier to fish at low flows) and on larger boulders. The site adjoined cutover bog and improved grassland (GA1), with scattered treelines of willow, elder and downy birch and scrubby understories adjoining the channel.

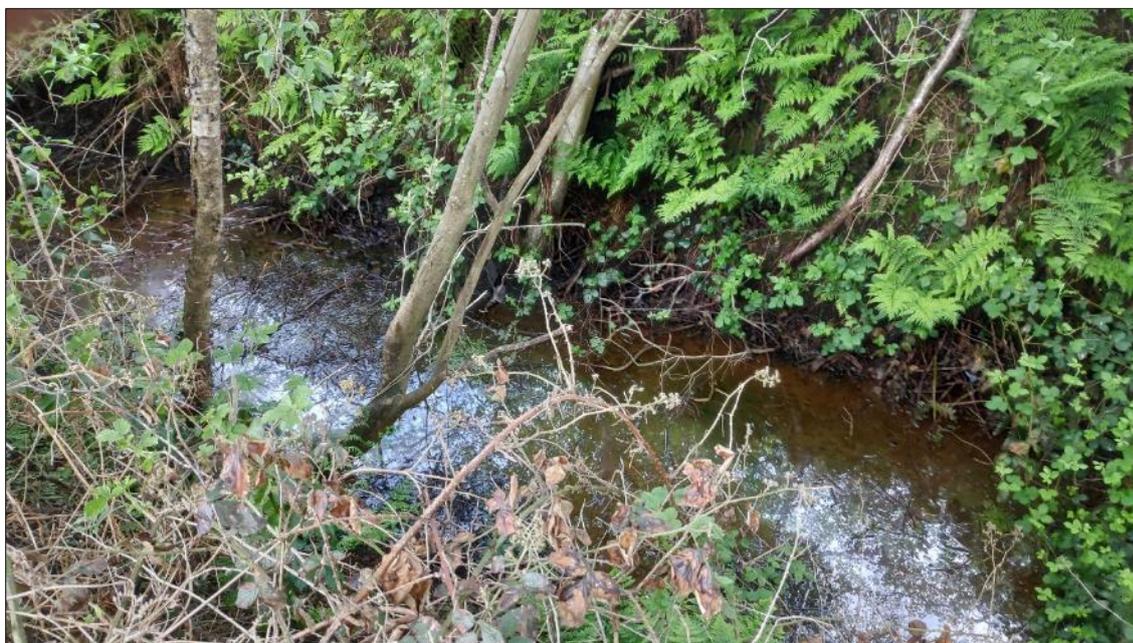
**Plate 4.9** Representative image of site B1 on the Killaconnigan Stream, May 2020 (semi-dry channel)

Site B1 was not suitable for Q-sampling during the survey period due to its semi-dry nature and lack of flow. Thus, it was not possible to assess biological water quality at this site.

Given the non-perennial nature of the stream at this location, the aquatic ecological evaluation of site B1 was of **local importance (lower value)**.

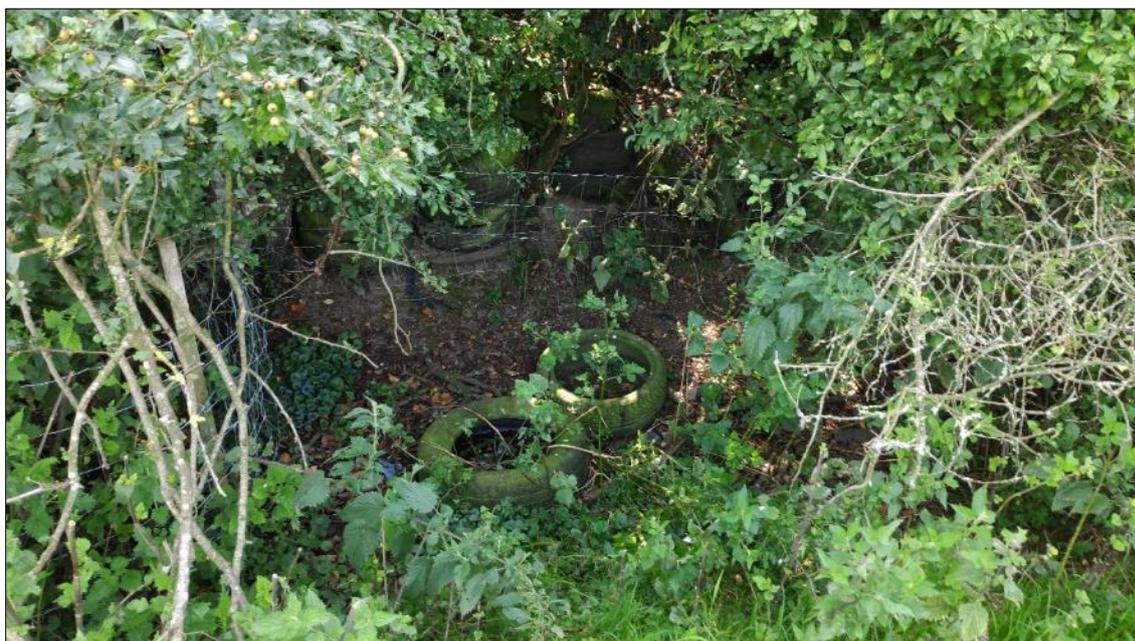
**Plate 4.10** Representative image of site B2 on the Kilballivor Stream, May 2020 (100% dry channel)

The aquatic ecological evaluation of site B2 was of **local importance (lower value) (Table 4.1)**.

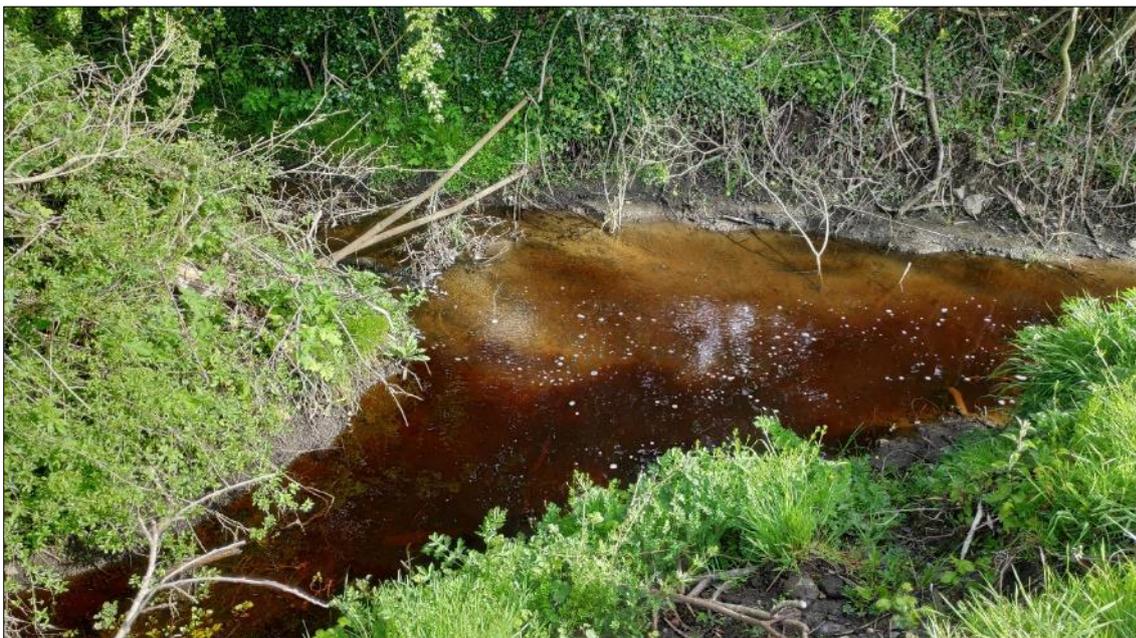
**Plate 4.11** Representative image of site B3, May 2021

Biological water quality, based on Q-sampling, was calculated as **Q3 (poor status) (Appendix B)**. No macro-invertebrate species of conservation value greater than 'least concern', according to national red lists, were recorded via Q-sampling.

The aquatic ecological evaluation of site B3 was of **local importance (lower value)**.

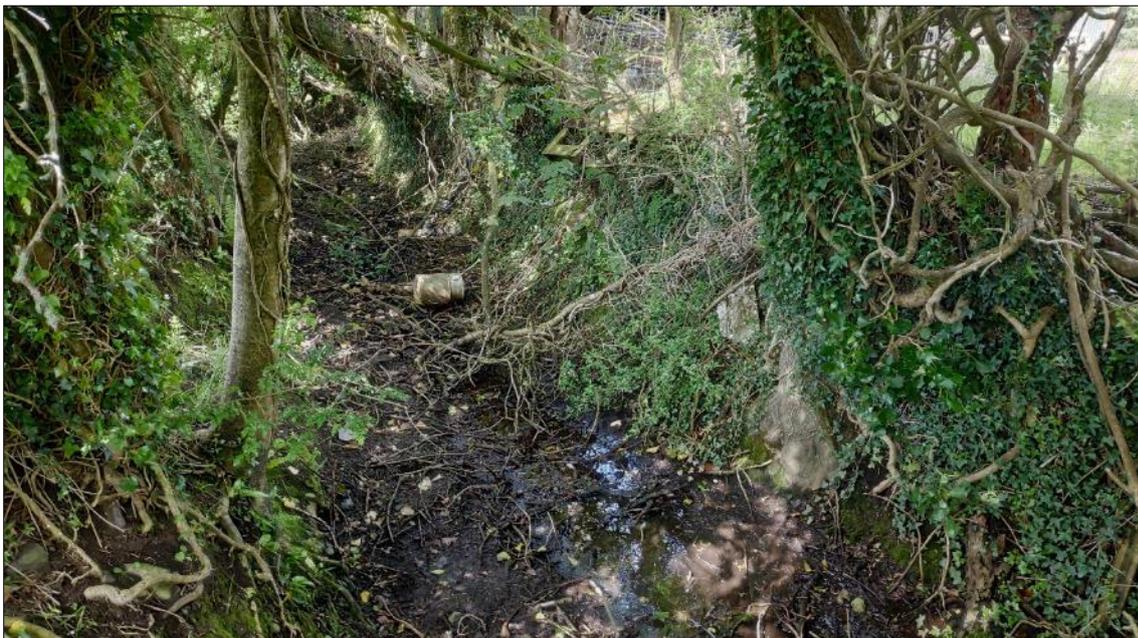
**Plate 4.12** Representative image of site B4 on unnamed Ballivor River tributary, May 2021 (dry channel)

Site B4 was not suitable for Q-sampling during the survey period due to its dry nature and lack of flow. Thus, it was not possible to assess biological water quality at this site.

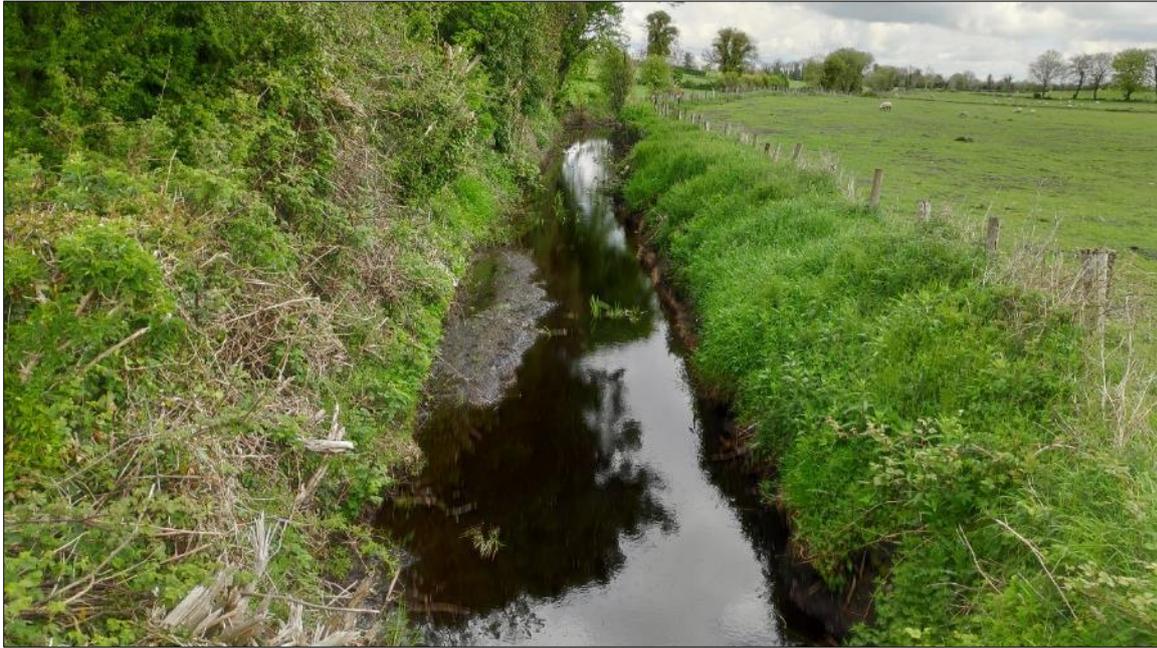
**Plate 4.13** Representative image of site B5 on the Ballivor River, May 2021 (facing downstream from bridge)

Site B5 was located on the upper reaches of the Ballivor River (07B52) at a local road crossing, approx. 1.5km downstream of the site boundary. The lowland depositing watercourse (FW2/FW4) had been straightened and deepened historically, with more recent maintenance evident downstream of the bridge. The channelised river was 3m wide and 0.2-0.3m deep on average. The water was peat-stained and had a moderate flow rate, but no broken riffle or glide

Biological water quality, based on Q-sampling, was calculated as **Q2-3 (poor status) (Appendix B)**. However, it should be noted that, given the absence of faster flowing riffle and glide habitat heavily, this is a **tentative** Q-rating. No macro-invertebrate species of conservation value greater than 'least concern', according to national red lists, were recorded via Q-sampling.

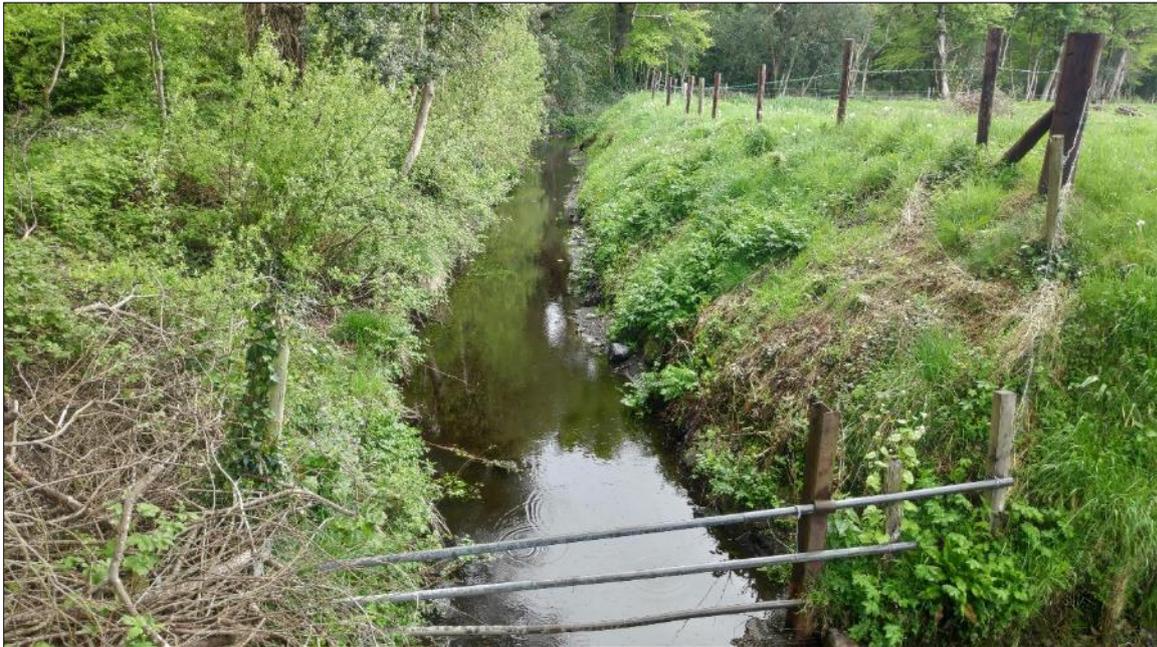
**Plate 4.14** Representative image of site C1 on the Graffanstown Stream, May 2021 (facing upstream from road culvert)

Biological water quality, based on Q-sampling, was calculated as **Q2-3 (poor status) (Appendix B)**. However, it should be noted that, given the absence of faster flowing riffle and glide habitat heavily, this is a **tentative** Q-rating. No macro-invertebrate species of conservation value greater than 'least concern', according to national red lists, were recorded via Q-sampling.

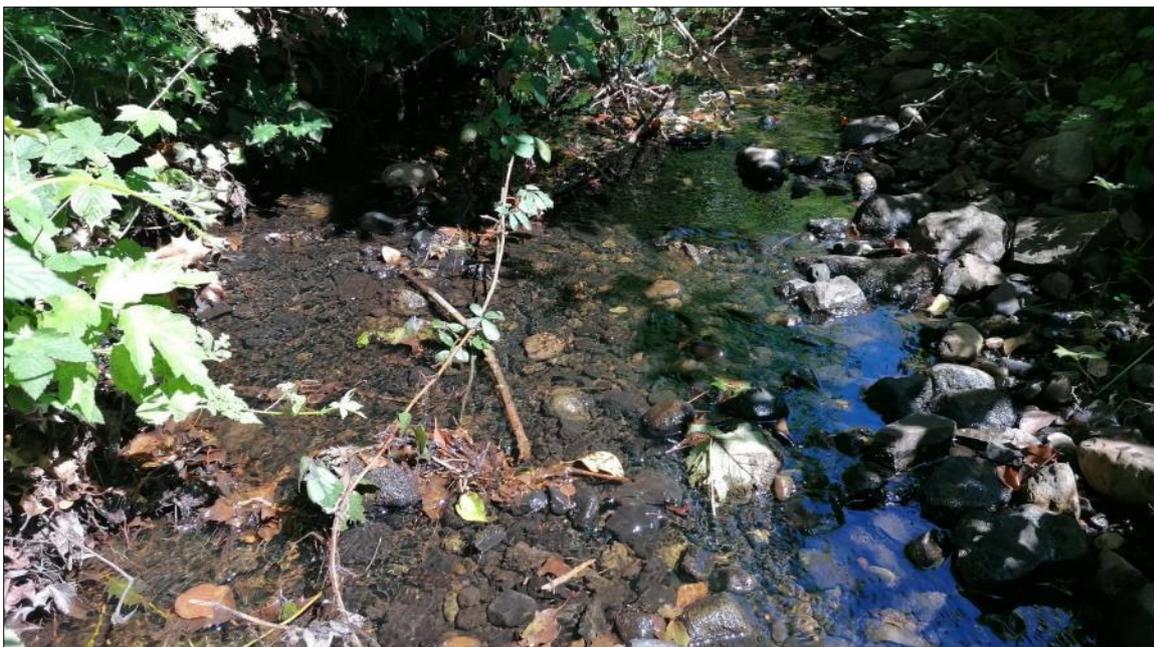
**Plate 4.15** Representative image of site C2 on the Ballynaskeagh Stream, July 2021

Biological water quality, based on Q-sampling, was calculated as **Q3 (poor status) (Appendix B)**. No macro-invertebrate species of conservation value greater than 'least concern', according to national red lists, were recorded via Q-sampling.

The aquatic ecological evaluation of site C2 was of **local importance (lower value)**.

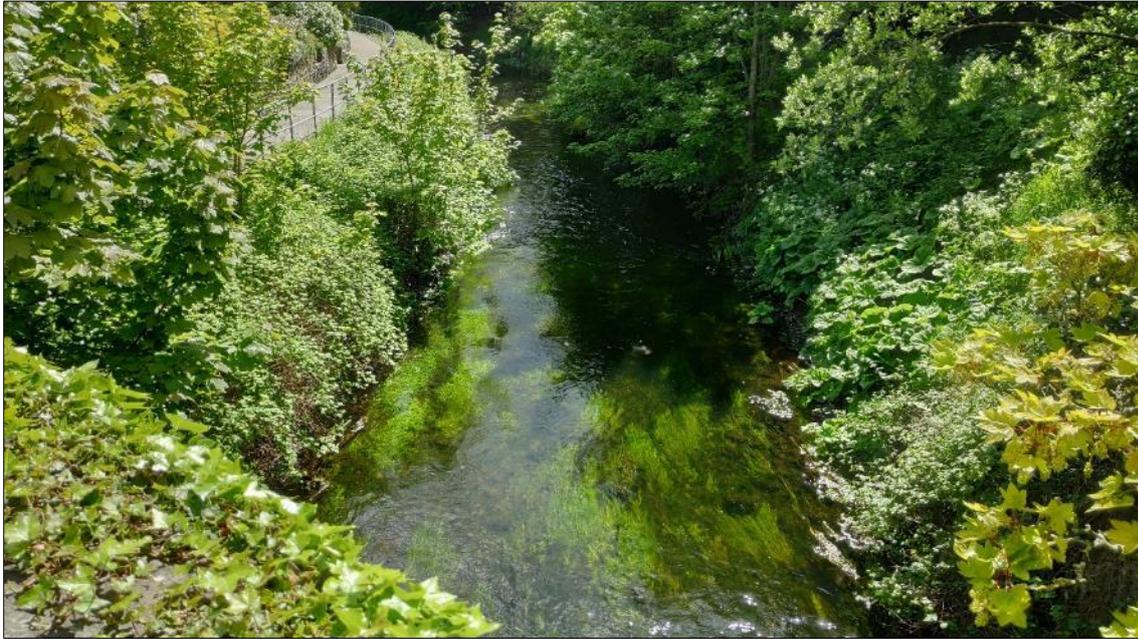
**Plate 4.17** Representative image of site C4 on the River Deel at Raharney Bridge, May 2021

Brown trout and Atlantic salmon were the only two fish species recorded via electro-fishing (**Appendix A**). Both were present in several cohorts and in relatively high densities. The site provided excellent-quality salmonid nursery habitat with well-oxygenated broken glide and riffle sequences and cover in macrophyte vegetation. The cobble substrata also provided good cover for juvenile salmonids. Good-quality spawning habitat was also present given unbedded, well-sorted mixed gravels between cobble areas. These had light siltation only. Holding habitat was also very good in deep glide and localised pool with overhanging tree cover and good shading. The site was also considered good for European eel, with ample boulder and cobble refugia, albeit none were recorded. No soft sediment lamprey habitat was identified present but the quality of spawning habitat was considered good. Lamprey species likely occur downstream of the survey area in suitable depositing areas. Despite some good suitability, no white-clawed crayfish were recorded and no contemporary records were available for the river (1980s only: see section 3.1). Otter foraging potential was high although no otter signs were recorded during the survey.

Given the location of the site within the River Boyne and River Blackwater SAC (002299), in addition to the presence of two Annex I aquatic habitats and qualifying interest Atlantic salmon, the aquatic ecological evaluation of site C4 was of **international importance**.

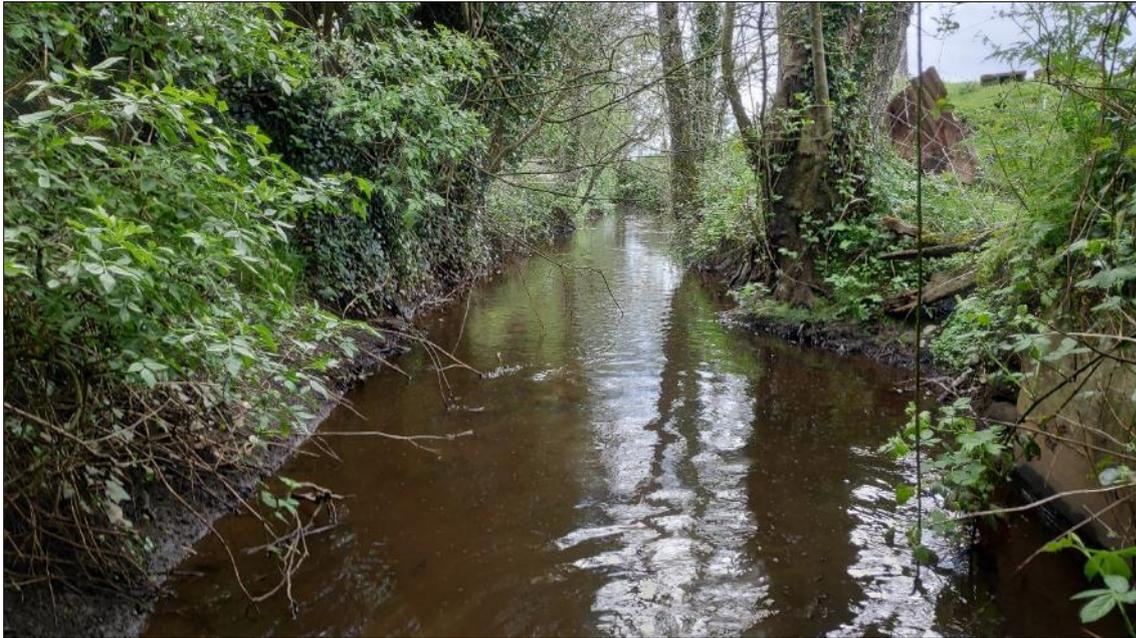
**Plate 4.18** Representative image of site C5 on the Craddanstown Stream, May 2021 (facing downstream from bridge)

loamy banks in which to burrow) the extensive channel modifications and high siltation created conditions inimical to white-clawed crayfish. A regular otter spraint site with associated prints was recorded on a muddy paludal area underneath the bridge (ITM 663341, 751542).

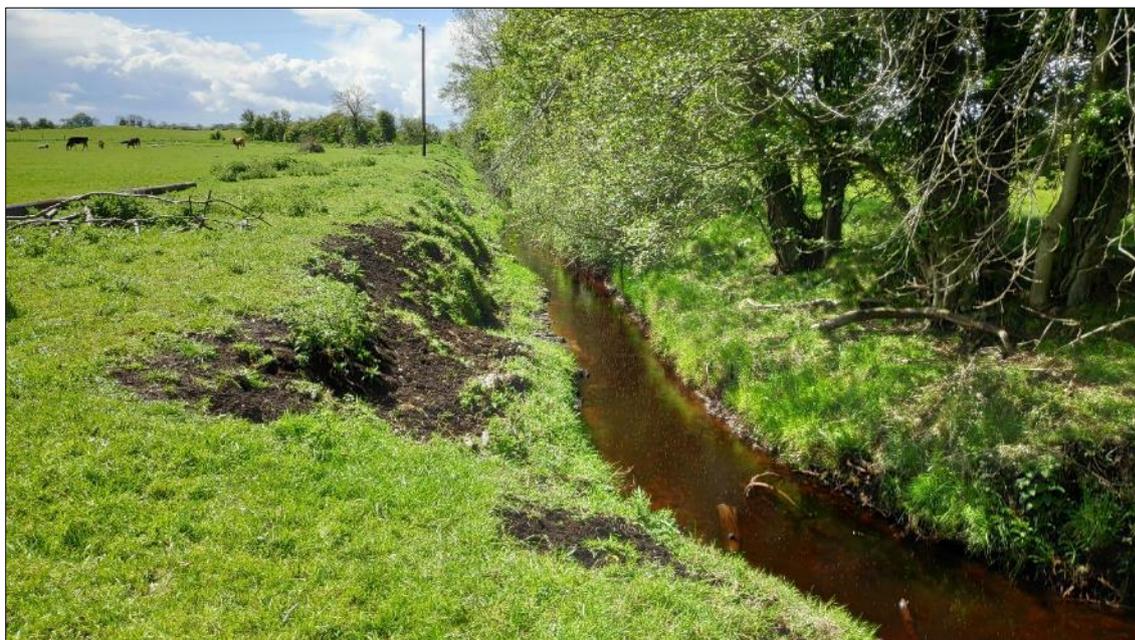
**Plate 4.19** Representative image of site C6 on the Clondalee More Stream, May 2021

Biological water quality, based on Q-sampling, was calculated as **Q2-3 (poor status) (Appendix B)**. No macro-invertebrate species of conservation value greater than 'least concern', according to national red lists, were recorded via Q-sampling.

The aquatic ecological evaluation of site C6 was of **local importance (lower value)**.

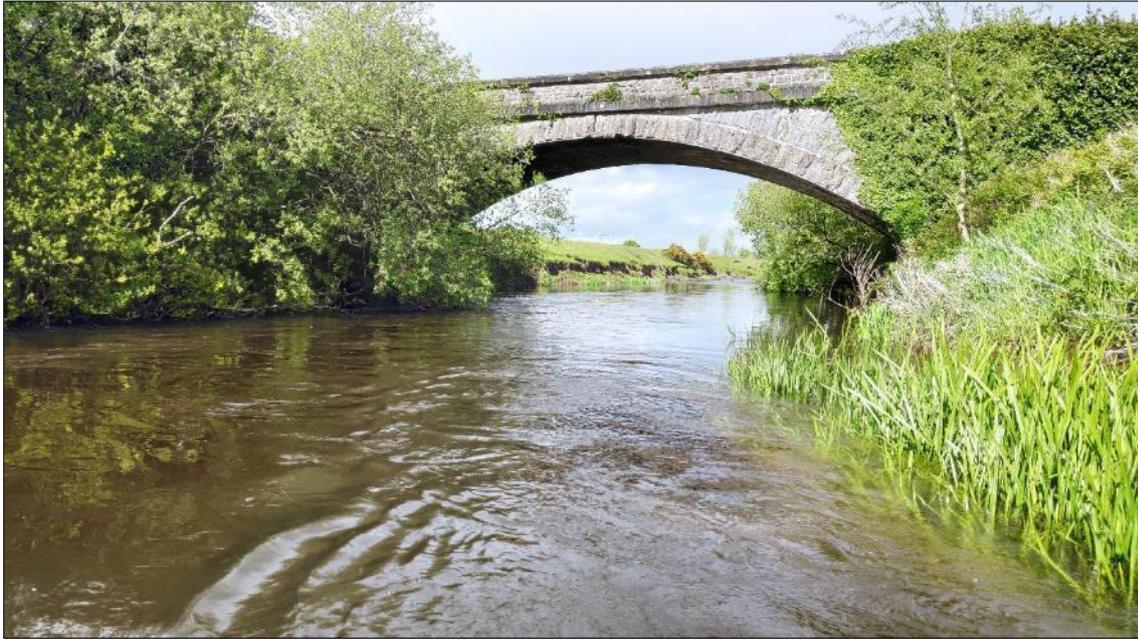
**Plate 4.20** Representative image of site D1 on the River Boyne, May 2021 (facing downstream)

Atlantic salmon, brown trout, stone loach (*Barbatula barbatula*) and minnow (*Phoxinus phoxinus*) were recorded via electro-fishing (**Appendix A**). Historical alterations had reduced the salmonid nursery value of the site. The spawning value was moderate as spawning gravels were restricted to isolated pockets between banks of argillaceous clay given historical deepening works. Holding habitat was very good. While no large salmonids were captured, larger fish were observed in deep pool adjoining the glide habitat surveyed - these areas were outside of wadable reach electro-fishing. Lamprey burial habitat was rare but present in association with marginal bur reed beds (however, no ammocoetes were recorded). European eel habitat was moderate with refugia largely limited to overhanging trees and scattered boulders. Some crayfish habitat was present but the bedded nature of the substrata and sparse macrophyte growth, in addition to the compacted banks, reduced the value overall in the vicinity of the bridge. The River Boyne also has a history of crayfish plague (*Aphanomyces astaci*) outbreaks which have periodically eradicated the species. Otter potential was high although no signs were recorded (few marking opportunities given the removal of boulder outcrops during historical dredging).

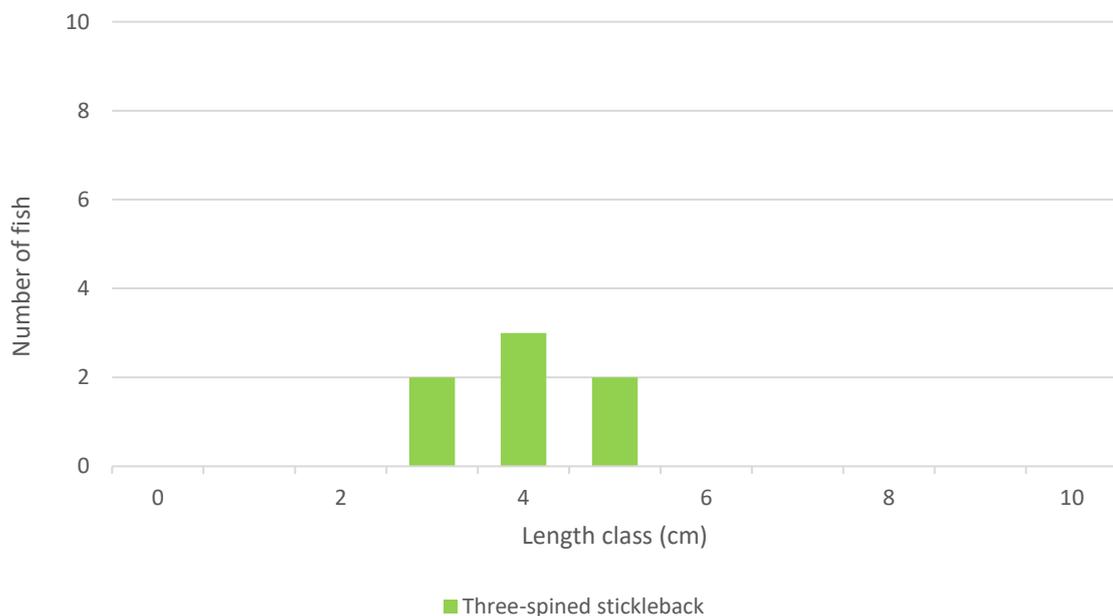
**Figure 3.1** Length frequency distribution recorded via electro-fishing at site A1 on the Cartenstown Stream, July 2021

Three-spined stickleback was the only fish species recorded via electro-fishing (**Figure 3.1**). With the exception of low densities of this species, the narrow, historically straightened and deepened channel was of very poor fisheries value, i.e., not of value to salmonids or lamprey species given the lack of flow and heavily-silted (peat) nature. The site featured 100% slow-flowing glide habitat and was considered likely non-perennial (i.e., dries up seasonally). Fisheries value improved further downstream where the channel became wider, deeper and more supportive of perennial aquatic habitats.

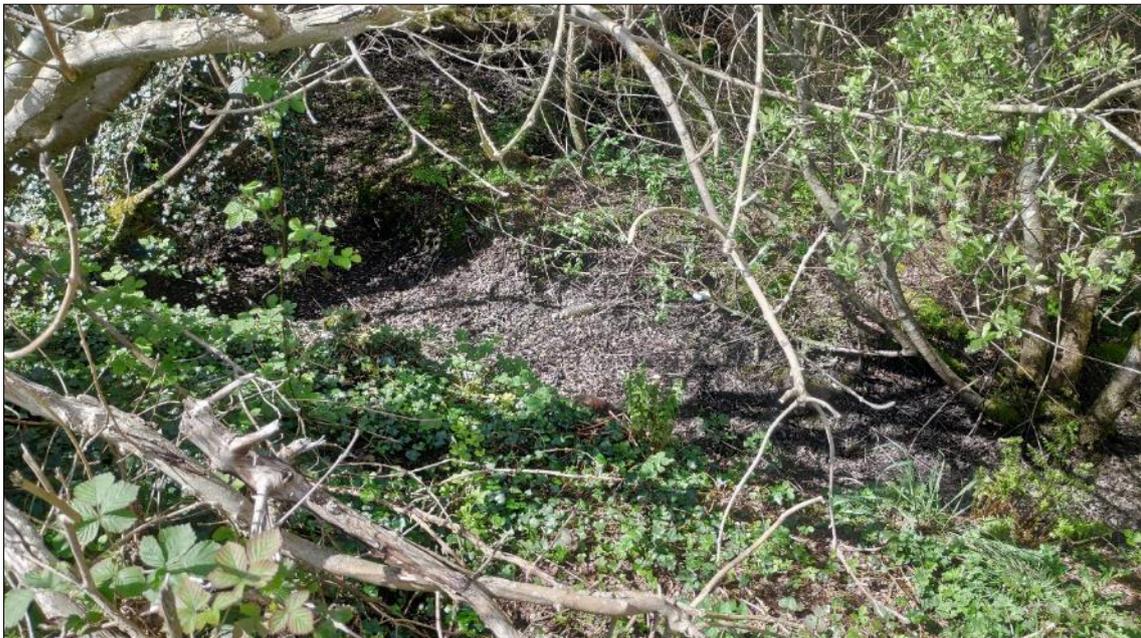
**Plate 3.2** Representative image of site A2 on the Stonestown River, May 2021

No fish were recorded from site A2 on the Stonestown River. The channel had been modified historically (straightened and deepened) and was 100% dry at the time of survey, with no pools of standing water remaining. Thus, the site had no fisheries value. The non-perennial channel drained cutover peat bog (PB4) and was evidently dry for much of the year.

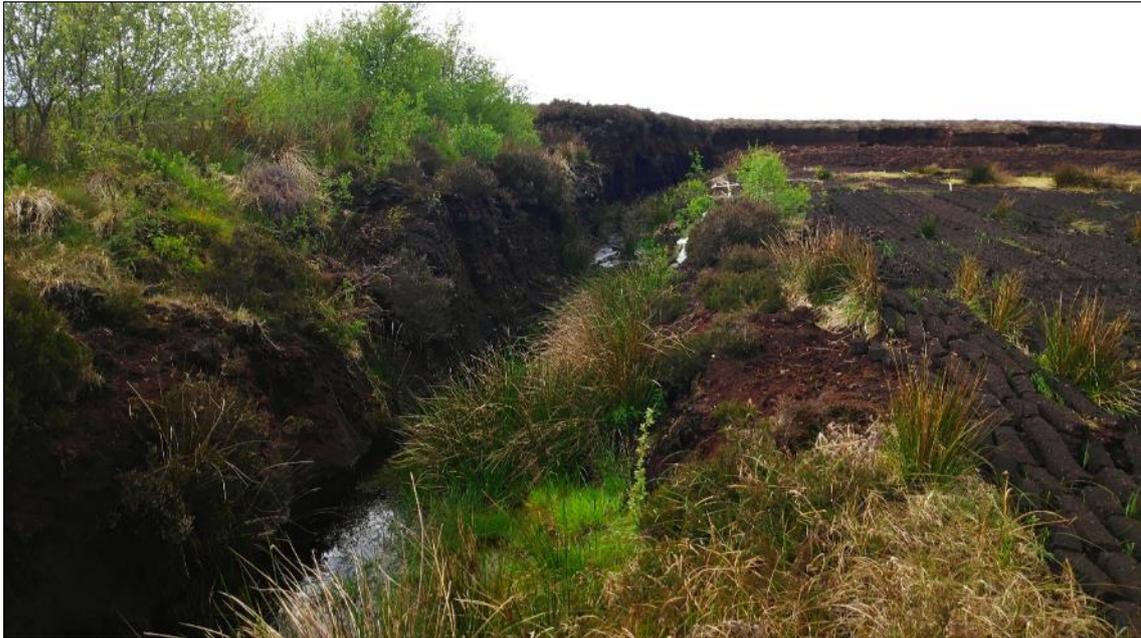
**Plate 3.6** Representative image of site A6 on the Woodtown West Stream, May 2021

No fish species were recorded via electro-fishing at site A6 on the Woodtown West Stream. The peat drainage channel was of no fisheries value, given the lack of flow and heavily-silted (peat) nature. The stream had an imperceptible flow with numerous instream blockages (100% standing water/ponding). The drainage channel was grossly silted (several silt dams present). Deeper pool areas downstream of the survey site may have supported low densities of three-spined stickleback, although the intermittent/non-perennial nature of the stream likely precluded fish presence in the upper reaches. Both common frog (*Rana temporaria*) and smooth newt (*Lissotriton vulgaris*) were recorded via sweep netting during the site visit.

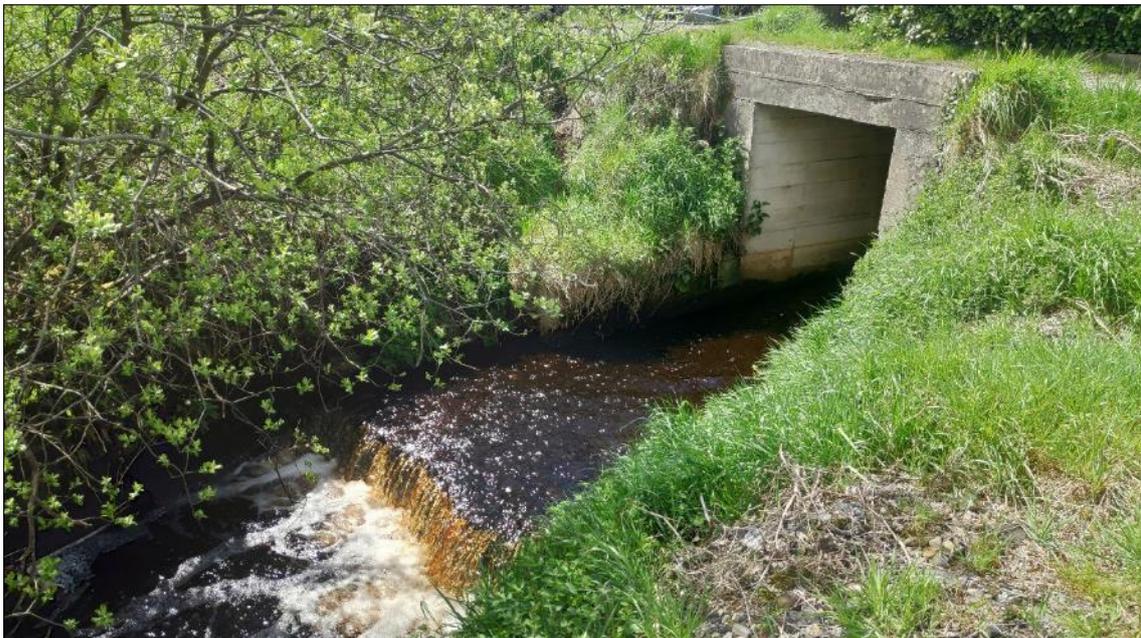
**Plate 3.8** Representative image of site A8 on the Carranstown Little River, May 2021

No fish were recorded via electro-fishing at site A8 on the Carranstown Little River. Suitability was limited to three-spined stickleback, although none were recorded present. The channel featured poor-quality salmonid nursery and spawning habitat, given high levels of peat-derived siltation (site drained an area of cutover bog). The site was not considered of good quality for European eel given the limited presence of accessible refugia such as cobble and boulder. Despite the presence of soft sediment accumulations, these were humic in nature (i.e., peat dominated) and not suitable for larval lamprey.

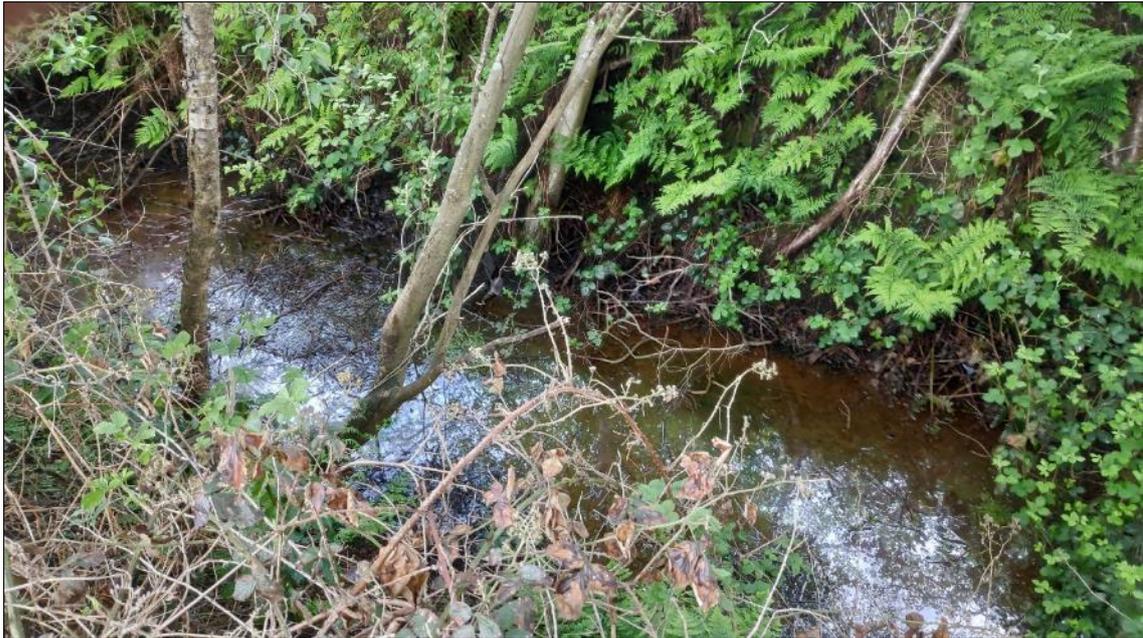
**Plate 3.9** Representative image of site B1 on the Killaconnigan Stream, May 2020

No fish were recorded via electro-fishing at site B1 on the Killaconnigan Stream, located adjacent to the R156 near the Ballivor Bord na Móna factory. The stream represented a semi-dry bog drainage channel (FW4) at the time of survey, with only pools of stagnant (standing) water present, i.e., no flow. The stream was evidently non-perennial at this location. Other than very low suitability for three-spined stickleback in the wider area (i.e., downstream of survey site), site B1 was not of fisheries value given its non-perennial and heavily-silted nature.
