### **AQUATIC ASSESSMENT**

# Aquatic baseline report for Ballivor wind farm, Co. Meath/Westmeath

Prepared by Triturus Environmental Ltd. for McCarthy Keville O'Sullivan Ltd.

**October 2021**

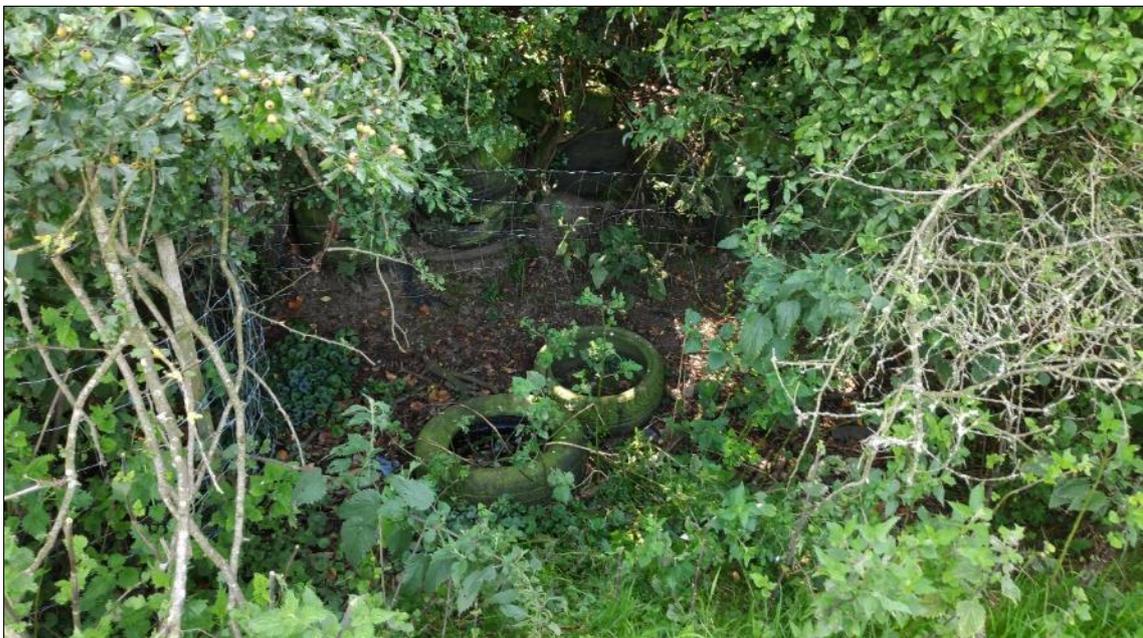
**Plate 3.10** Representative image of site B2 on the Kilballivor Stream, May 2020 (100% dry)

No fish were recorded from site B2 on the Kilballivor Stream. The channel had been modified historically (straightened and deepened) and was 100% dry at the time of survey, with no pools of standing water remaining. Thus, the site had no fisheries value. The non-perennial channel drained cutover peat bog (PB4) and was evidently dry for much of the year.

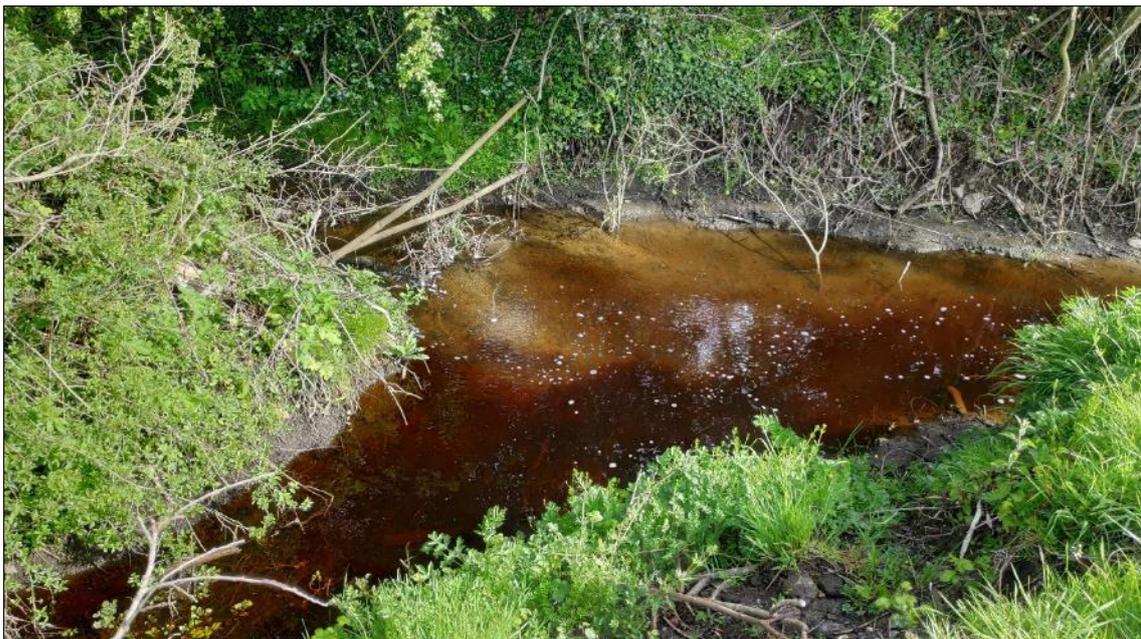
**Plate 3.11** Representative image of site B3 at the confluence of two unnamed streams, May 2021

Three-spined stickleback was the only fish species recorded via electro-fishing at site B3 on an unnamed Ballivor River tributary (**Figure 3.6**). With the exception of low densities of this species, the heavily silted channel was of very poor fisheries value, i.e., not of value to salmonids given the lack of flow and heavily-silted (peat) nature. Some low potential for European eel and *Lampetra* sp. was present but none were recorded. The site had been extensively straightened and deepened in the recent past with poor instream recovery evident.

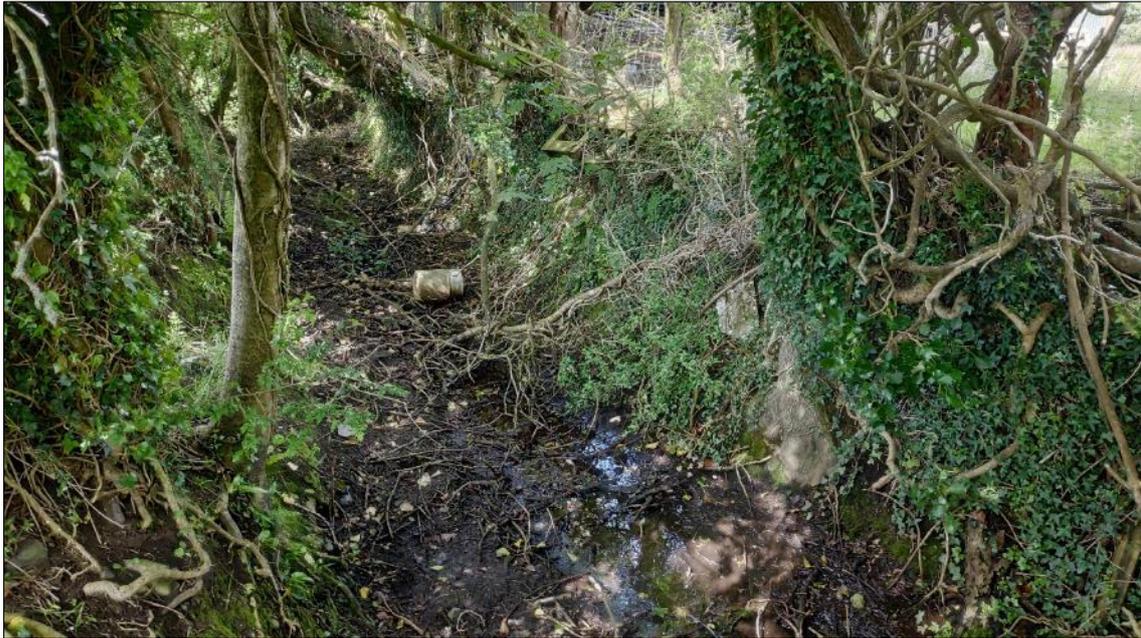
**Plate 3.12** Representative image of site B4 on unnamed Ballivor River tributary, May 2021 (dry channel)

No fish were recorded via electro-fishing at site B4 on an unnamed Ballivor River tributary. The channel was 100% dry at the time of survey, with no ponding or stagnant water present (i.e., non-perennial channel). The river had no aquatic or fisheries value given the lack of water at the time of survey. The channel was considered likely to convey water intermittently during the year (i.e., mostly dry) and thus may have some very low value as a stickleback habitat. The downstream-connecting Ballivor River (0.7km downstream) was of some moderate fisheries and aquatic value.

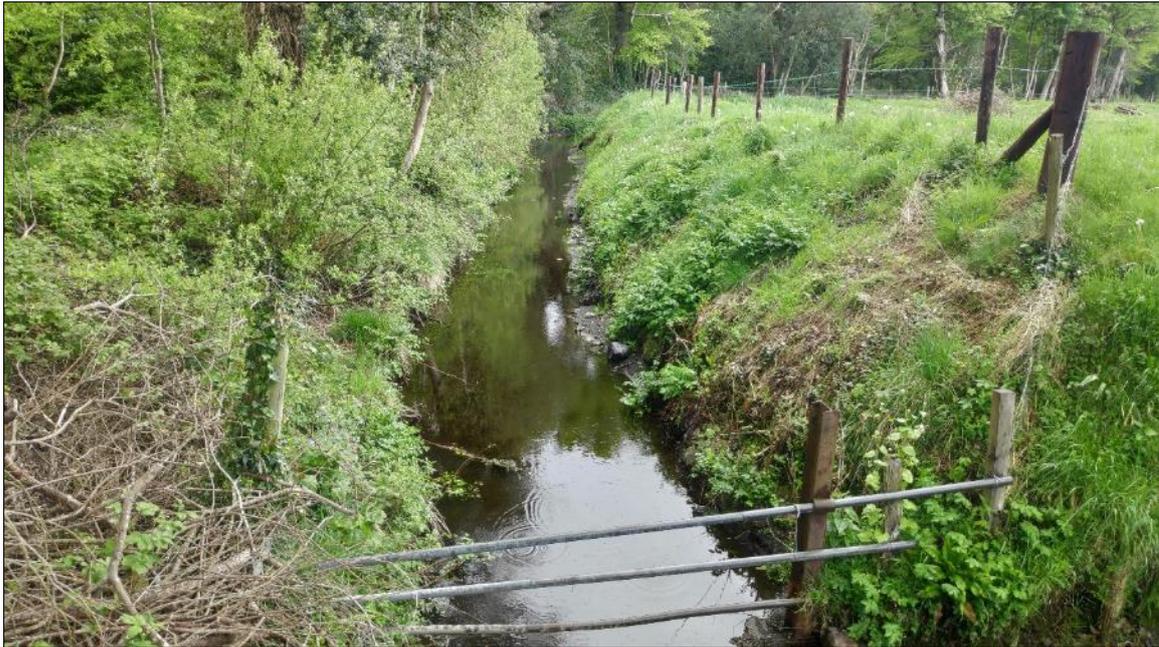
**Plate 3.14** Representative image of site C1 on the Graffanstown Stream, May 2021 (facing upstream from road culvert)

Three-spined stickleback was the only fish species recorded via electro-fishing at site C1 on the Graffanstown Stream (**Figure 3.8**). With the exception of very low densities of this species, the heavily silted and enriched drainage channel was of very poor fisheries value, i.e., not of value to salmonids or lamprey species given the lack of flow and heavily-silted (peat) nature. Whilst some limited sands and fine gravels were present on top of the flocculent sediment in places (e.g., near meander 40m upstream of culvert), these were also heavily silted. Despite an abundance of soft sediment accumulations, these were not of value for larval lamprey given the flocculent and or high humic content, in addition to poor flows.

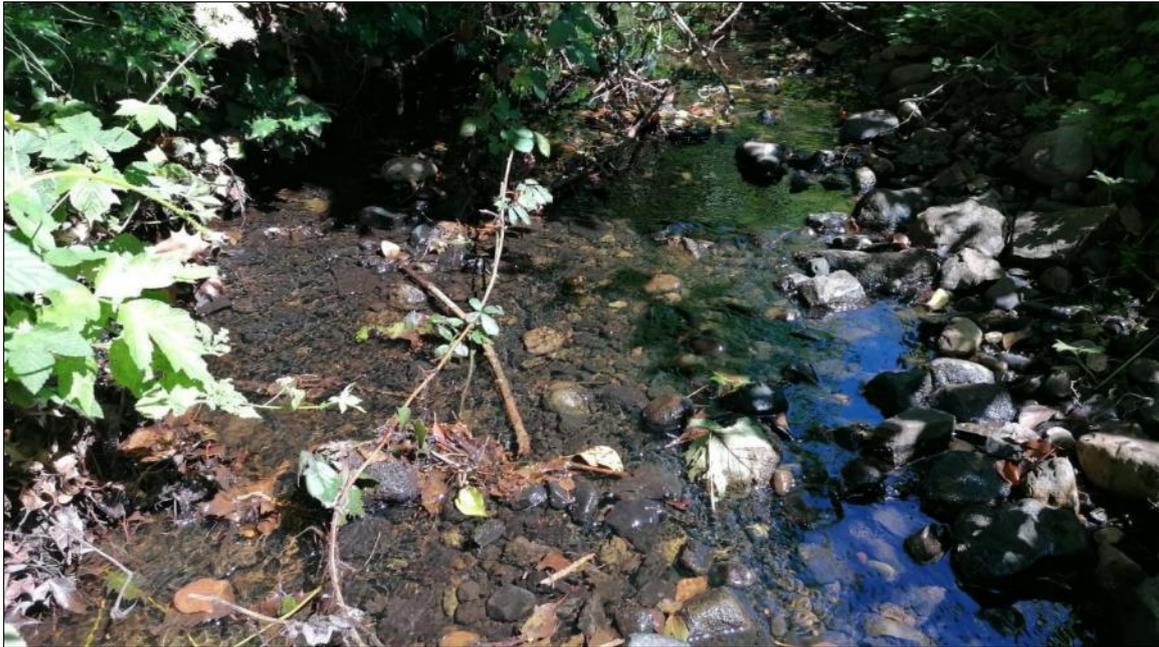
**Plate 3.15** Representative image of site C2 on the Ballynaskeagh Stream, July 2021

No fish were recorded via electro-fishing at site C2 on the Ballynaskeagh Stream. Despite some moderate physical habitat suitability for salmonids and lamprey, these species were absent. This was considered a result of very low water levels at the time of survey (average depth <0.05m) and the stream's likely non-perennial nature. Nevertheless, even during higher water levels (e.g., winter), the site would only provide (at best) moderate suitability, given high rates of siltation and compacted substrata. There was some low suitability for European eel, albeit none were recorded. Improved fisheries habitat was present in the lowermost reaches at the River Deel confluence and River Boyne and River Blackwater SAC (002299) site boundary.

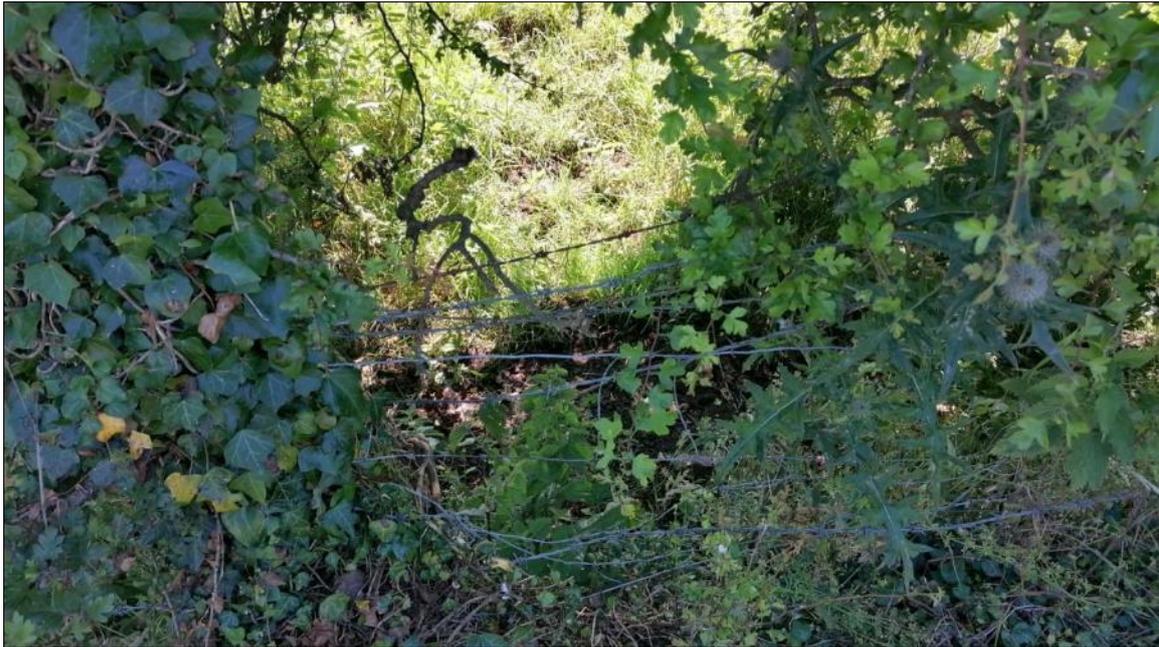
**Plate 3.16** Representative image of site C3 on the Mucklin Stream, July 2021 (100% dry channel)

No fish were recorded via electro-fishing at site C2 on the Mucklin Stream. The channel was 100% dry at the time of survey, with no ponding or stagnant water present (i.e., non-perennial channel). Thus, the stream had no aquatic or fisheries value given the lack of water at the time of survey. The channel was considered likely to convey water intermittently during the year (but mostly dry). Fisheries and aquatic value was high in the downstream-connecting River Deel, located <200m downstream. The lowermost reaches of the channel were likely of some low fisheries and aquatic value during high water levels (i.e., refuge from flood water on the River Deel).

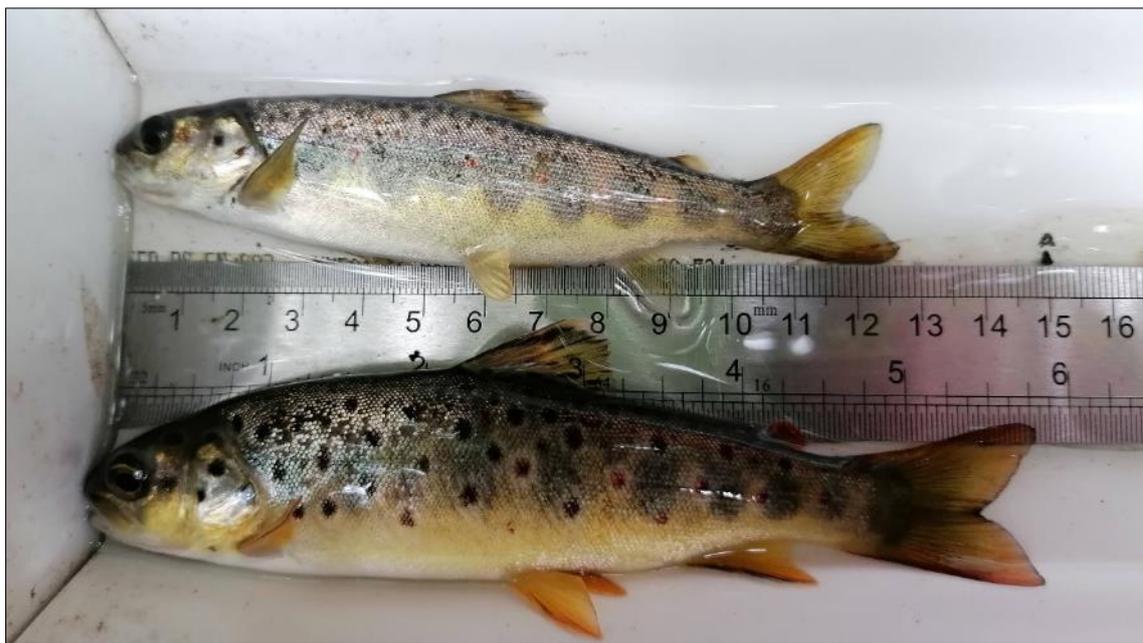
**Plate 3.17** Atlantic salmon (top) and brown trout (bottom) recorded from site C4 on the River Deel at Raharney Bridge, July 2021

A total of two fish species were recorded via electro-fishing at site C4 on the River Deel (**Figure 3.9**). Brown trout dominated the site ( $n=40$ ), with a range of cohorts present. Adults were more numerous than juveniles. Two distinct cohorts of Atlantic salmon parr (likely 0+ and 1+) were also recorded ( $n=21$  in total).

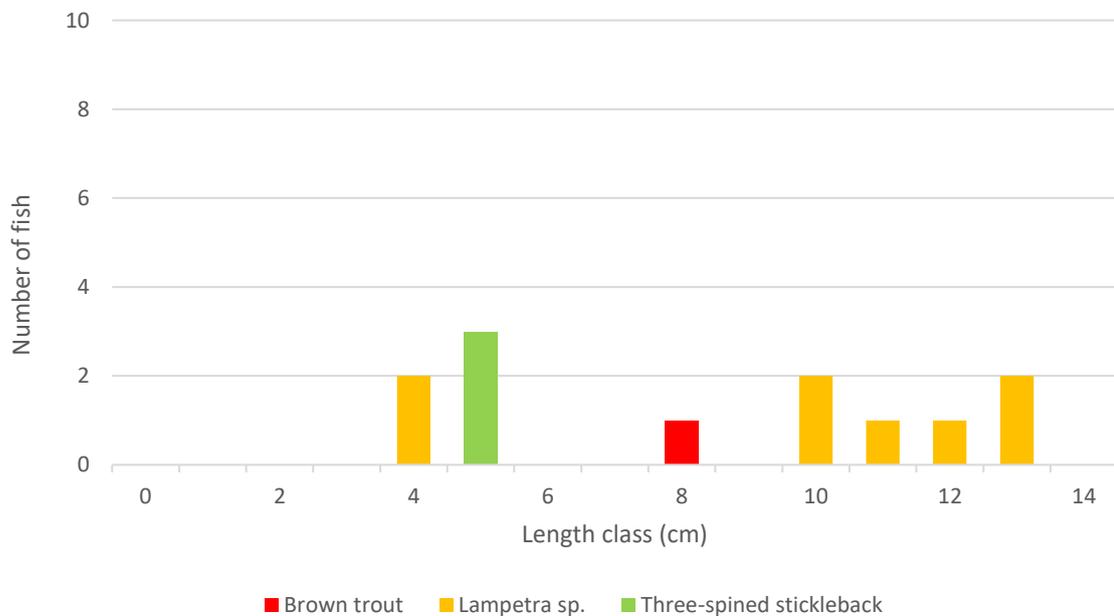
**Figure 3.10** Length frequency distribution recorded via electro-fishing at site C5 on the Craddanstown Stream, July 2021

The historically straightened site had negligible nursery, spawning and holding value for salmonids given the absence of riffle, glide and pool sequences and extreme levels of siltation. These were exacerbated by historical channelisation and sedimentation pressures from the adjoining improved grassland. The channel was not considered of value to European eel given the absence of refugia such as cobble and boulder and the shallow nature. The channel was, however, of some value to *Lampetra* sp. given pockets of fine silt with a high organic content up to 15cm deep. These adjoined degraded areas of fine gravel that provided some local spawning habitat for the species.

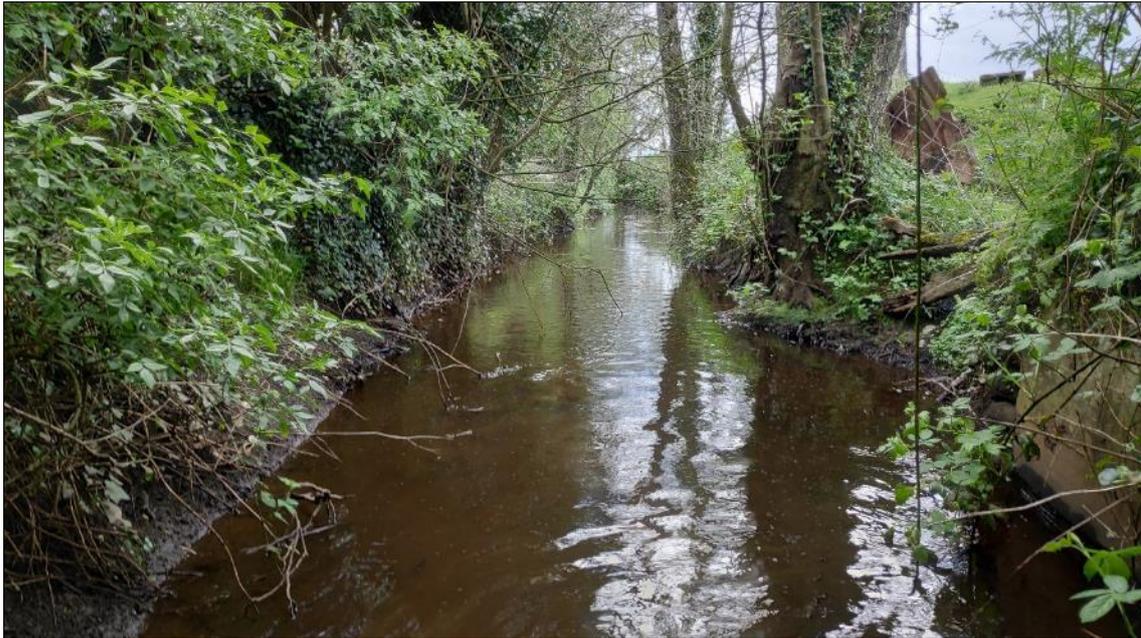
**Plate 3.18** Representative image of site C5 on the Craddanstown Stream, May 2021 (facing downstream from bridge)

A total of three fish species were recorded via electro-fishing at site C5 on the Craddanstown Stream (**Figure 3.10**). Low densities of three-spined stickleback ( $n=3$ ) and *Lampetra* sp. ( $n=8$ ) were recorded, in addition to a single juvenile (0+) brown trout. Low densities of larval lamprey were recorded at 0.8 per  $m^2$  (10 $m^2$  of habitat targeted and  $n=8$  ammocoetes captured).

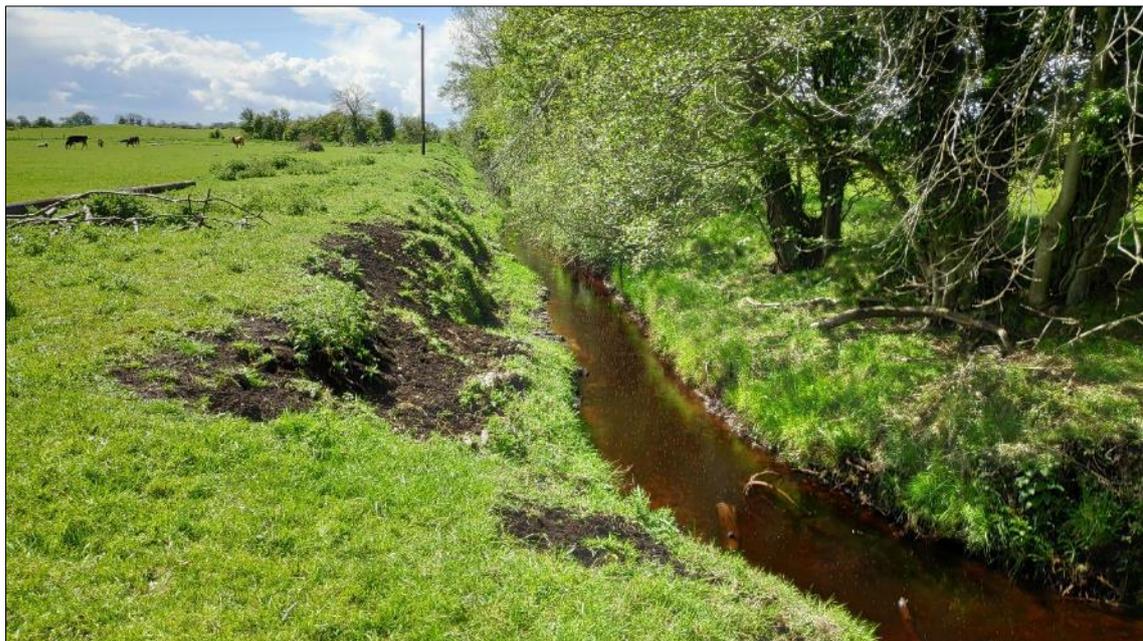
**Plate 3.19** Representative image of site C6 on the Clondalee More Stream, May 2021

Three-spined stickleback was the only fish species recorded via electro-fishing at site C6 on the Clondalee More Stream (**Figure 3.11**). With the exception of low densities of this species, the historically straightened channel was of very poor fisheries value, i.e., not of value to salmonids or lamprey species given the lack of flow and heavily-silted (peat) nature. Despite an abundance of soft sediment accumulations, these were not of value for larval lamprey given the flocculent and or high humic content, in addition to high clay fractions, locally, resulting in compaction. Suitability for European eel was low given the open, shallow nature of the site and paucity of suitable refugia.

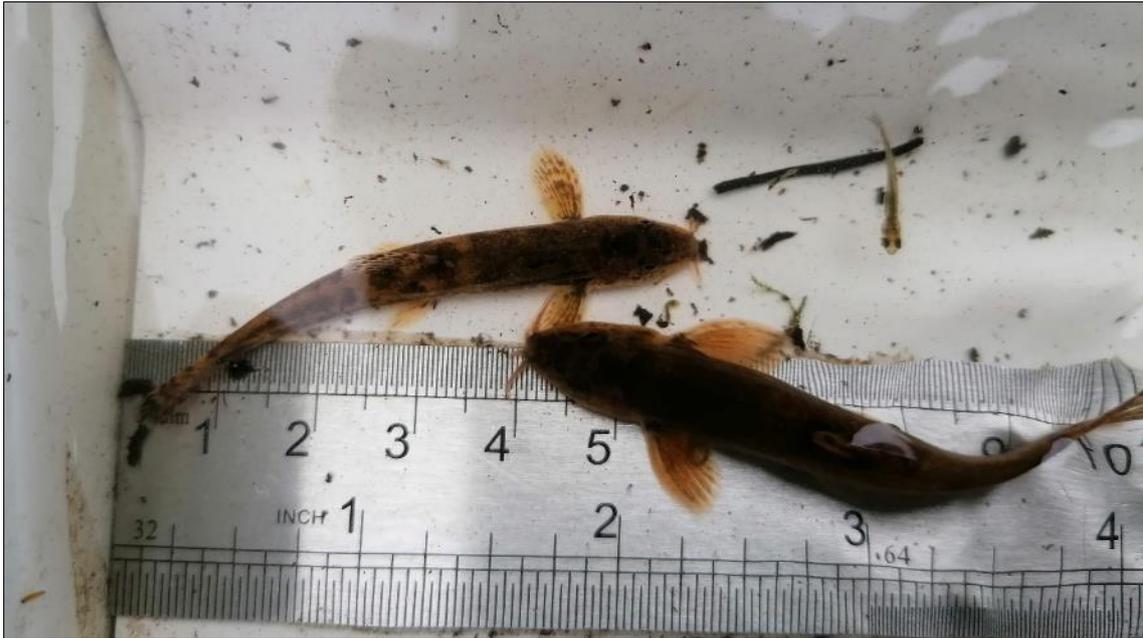
**Plate 3.20** Stone loach recorded from site D1 on the River Boyne, July 2021

A total of four fish species were recorded via electro-fishing at site D1 on the River Boyne (**Figure 3.12**). Low numbers of both Atlantic salmon parr ( $n=9$ ) and brown trout ( $n=5$ ) were recorded, in addition to low numbers of minnow ( $n=5$ ) and stone loach ( $n=4$ ). With the exception of one adult brown trout, all salmonids captured were of the 0+ cohort.
