Response to Observations Received

Ballivor Wind Farm (ABP
Ref. 316212)

Document Title: **Response to Observations Received**

Prepared By: **MKO
Tuam Road
Galway
Ireland
H91 VW84**

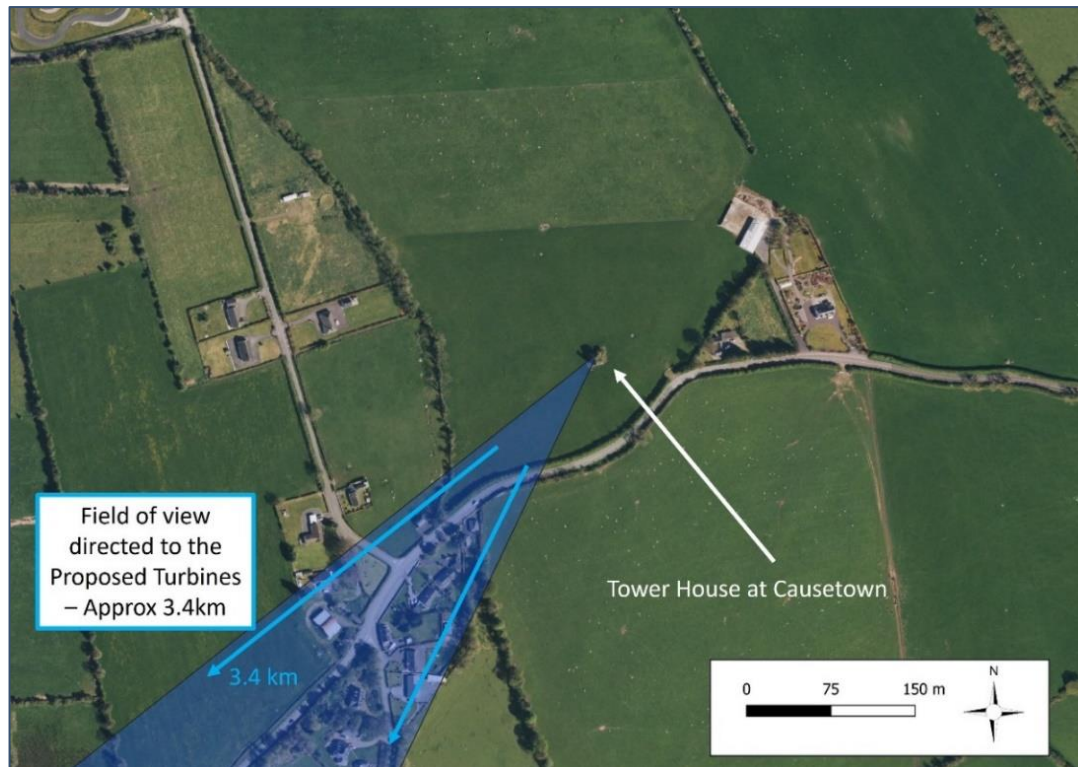
Figure 1. Causetown Tower House Field of View

As shown in Figure 1 below, the Tower House at Causetown is located within an agricultural field comprising grassland pasture. The proposed turbines are located to the south-west as indicated by the blue arrows. The receptors in this area include the N51 to the south, as well as a local road which runs north-south along fields to the west. Several residential receptors are aligned along this road network to the east, south-west and west of the tower. Lands to the north of the tower comprise uninhabited agricultural land.

A desktop investigation of this receptor did not indicate any public access or right of way to the heritage site, and it is not considered to be a destination attracting high visitor numbers. Therefore, from an LVIA perspective, it is not considered a receptor of high sensitivity, and sensitivity is only derived from its value as a local landmark in the landscape. The desktop study and map above also determined that receptors in the area (not within the private lands) can only really view and appreciate the monument and its setting from the south, east or west. Considering the proposed turbines are located to the south-west (3.4km) they will not be viewed in combination with any of the receptors identified (roadside residences). Irrespective of the orientation from receptors, it is unlikely that the proposed turbines will have much visibility in combination with the tower due to the setback distance and dense vegetation screening in the flat landscape.

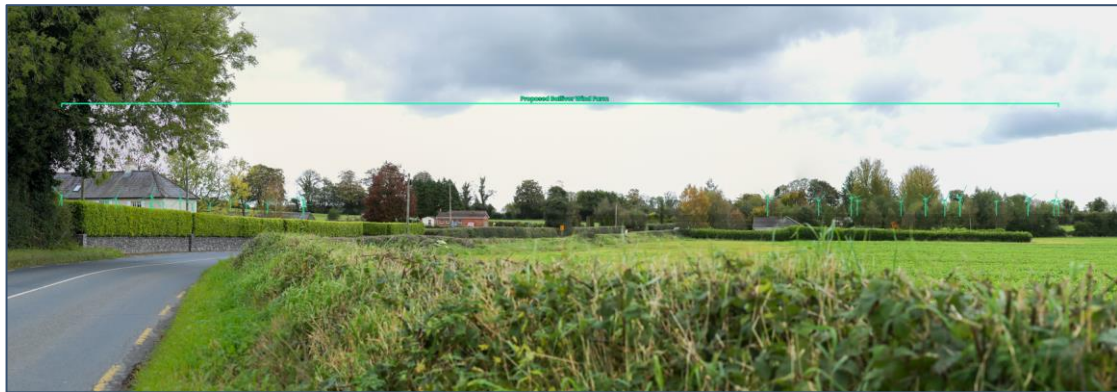
Figure 2. Barrow at Rathwire Upper Photowire

Although the landscape is undulating in this area, in general, at a macro scale, the landscape is still quite flat. In general, long ranging views are not permitted due to screening from boundary vegetation and slight landform undulations, excepting from elevated vantage points. Photomontage imagery was captured from a slightly elevated location on the R156 Regional Road as it exits Killucan to the east. The view is focussed in the direction of the Proposed Development, approximately 2 km east of the monument (2km closer to the proposed turbines). A photowire (early-stage photomontage) was produced from this location here and is presented below in Figure 2. As shown by the photowire, almost all of the proposed turbines will be screened from view completely, therefore this viewpoint was not included in the

photomontage booklet. However, the photowire does illustrate the limited visibility of the proposed turbines that is expected to occur within this area of the landscape.

A desktop investigation of the Barrow monument indicates that it does not represent a high sensitivity receptor from an LVIA perspective for the same reasons reported above for the Tower House at Causetown (e.g., visitor numbers, lack of public access). Considering the setback distance (c.8 km) and setting of the Barrow in a field enclosed by boundary vegetation to the west, it is considered that the Proposed Development is not likely to cause any significant impacts upon the character or appreciation of this receptor and its setting.

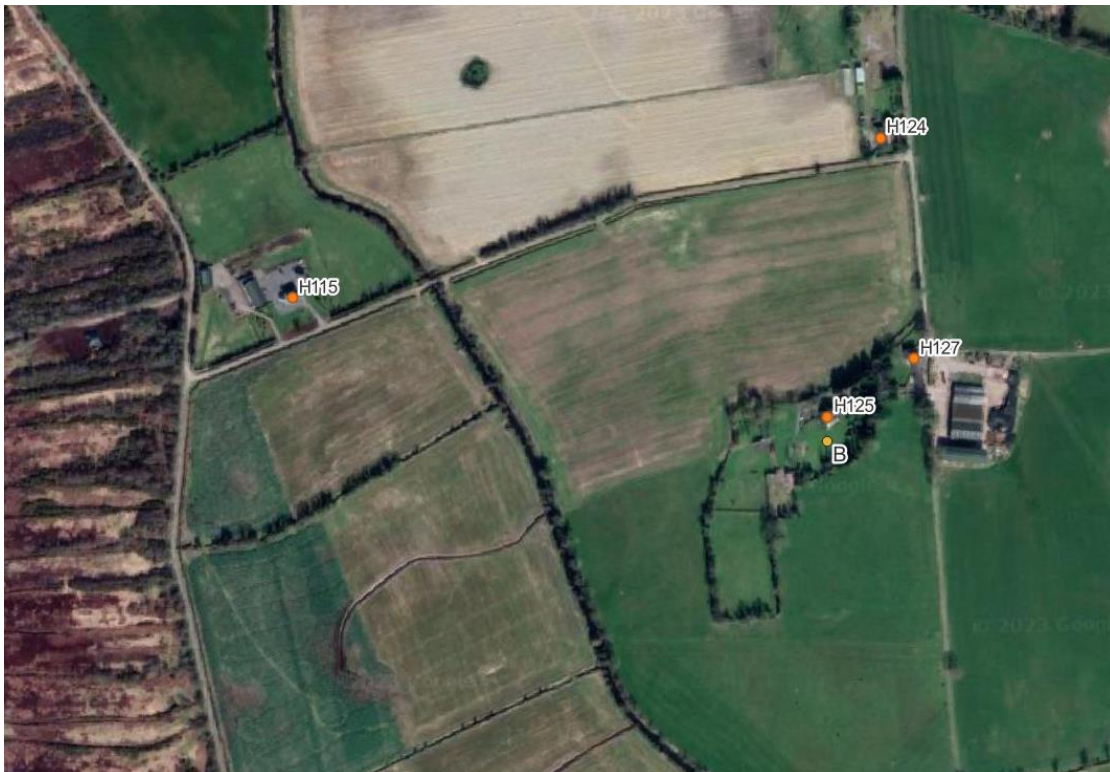
Figure 3. Noise Survey Location B at house H125

It is confirmed that the analysis of the data recorded at this location and presented in the Chapter 11 of the EIAR considered the correct noise survey position, shown as 'B' in Figure 3 below.

Mapping of Survey Location H125 and Status of Property The residents at H125 write that they facilitated a background noise survey in the grounds of their house, but that the location of this noise survey is not correctly reported in the EIAR. Table 11.4 of the EIAR incorrectly reports the noise survey location to be H115 with coordinates E666,471 N759,713 whereas the correct house reference is H125, and the correct coordinates are E666,983, N759,576. The correct monitoring location is shown in Figure 3 below.

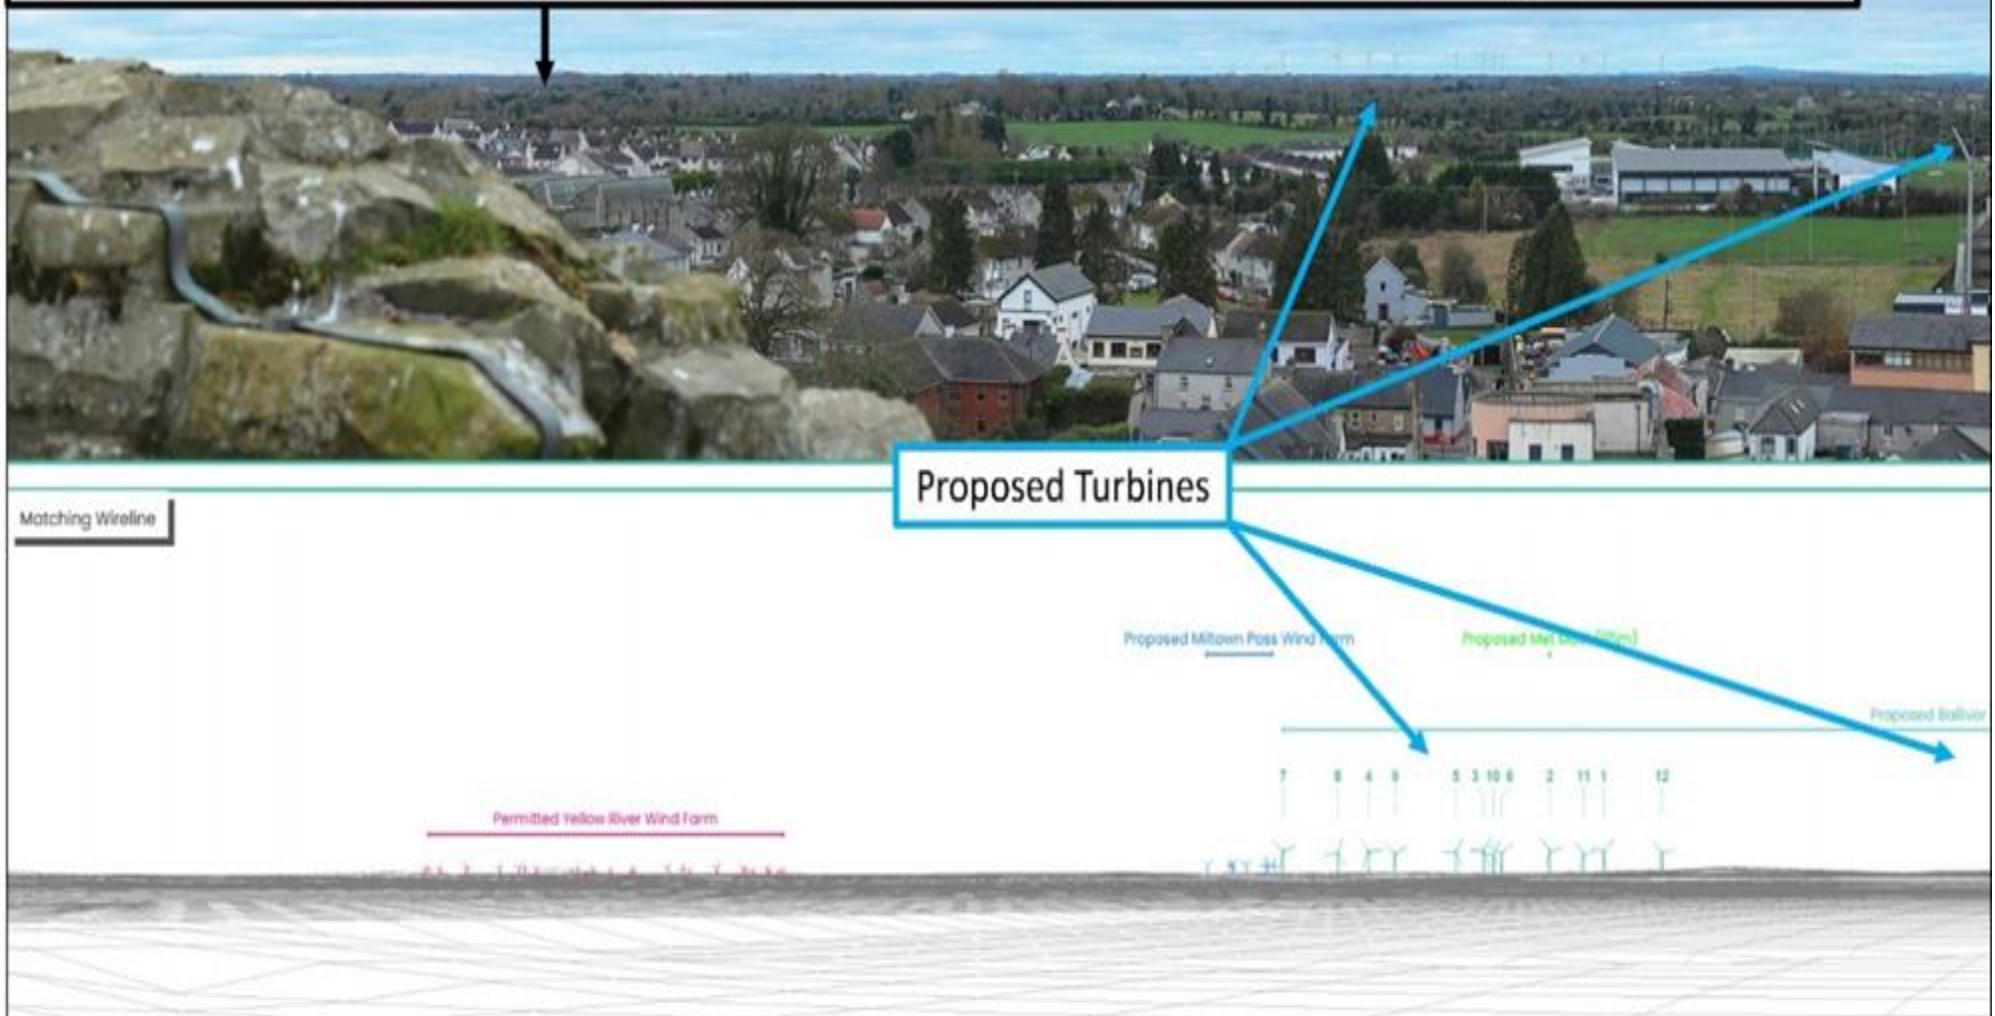
Figure 4. Viewpoint 19

VP19 – Trim Castle: Viewpoint 19 shows views from the most elevated ramparts of Trim Castle. An assessment of the proposed turbines from this location is included in Appendix 13-3 and summarised in the EIAR LVIA. The under construction Friarspark Solar Farm (including extension) is theoretically visible in combination with the proposed turbines within the field of view presented in Viewpoint 19 considering elevated nature and orientation of views from the viewpoint. Analysis of the layout of this solar farm and the photomontage determined that this solar farm will not be visible in the photomontage (or from Trim Castle ramparts when constructed). As demonstrated by the image above, visibility and potential for cumulative visual effects will not occur due to the surface level nature of solar development and dense screening from the mature treelines which form boundaries of 6 No. fields located between the solar farm and the urban fringe of Trim town.

Under construction Friarspark Solar Farm not visible from VP19 due to screening from mature woodland along the 6 No. field boundaries in the intervening landscape between the solar farm and the urban fringe of Trim town.

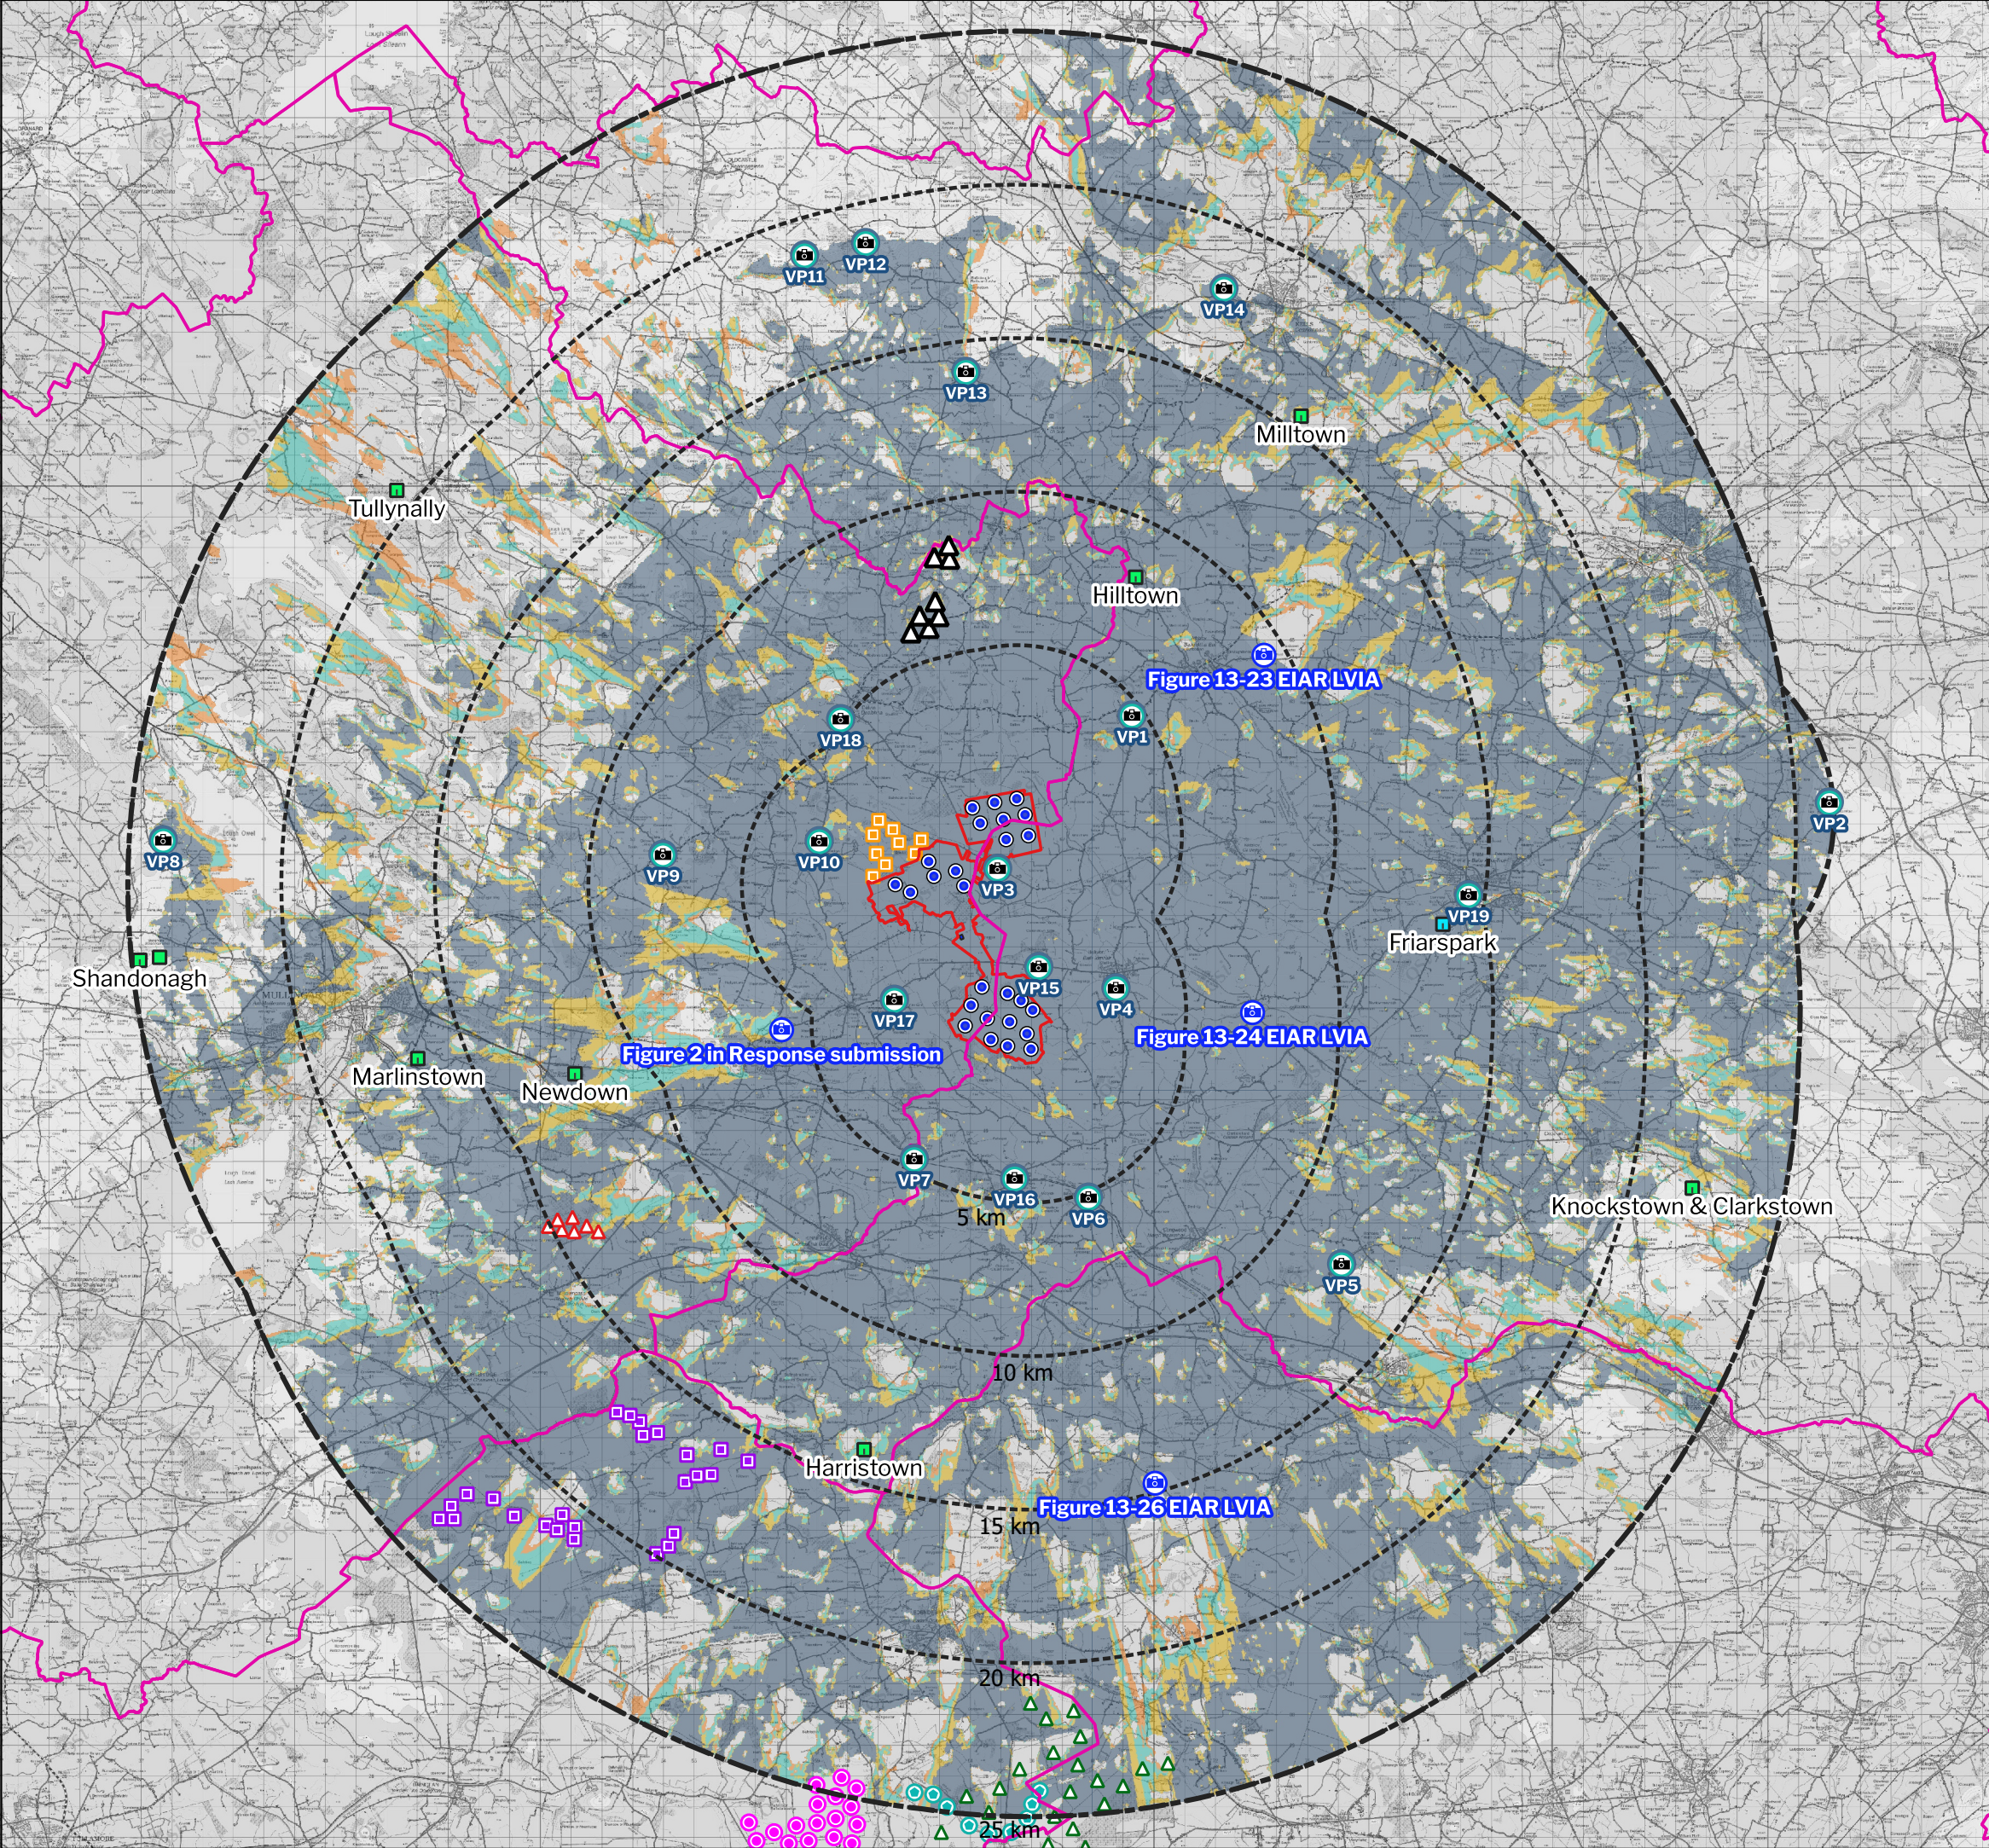
In light of this information being recently available, and for consideration by the board, the proposed turbines of the Knockanarragh wind farm are included in Figure 5 below. For context, and in mind of the other request for information about cumulative impacts with solar farms, Figure 5 also includes turbines of the Proposed Ballivor Wind Farm Development, other cumulative wind and solar energy developments, the ZTV map and the location of photomontages included in the EIAR LVIA.

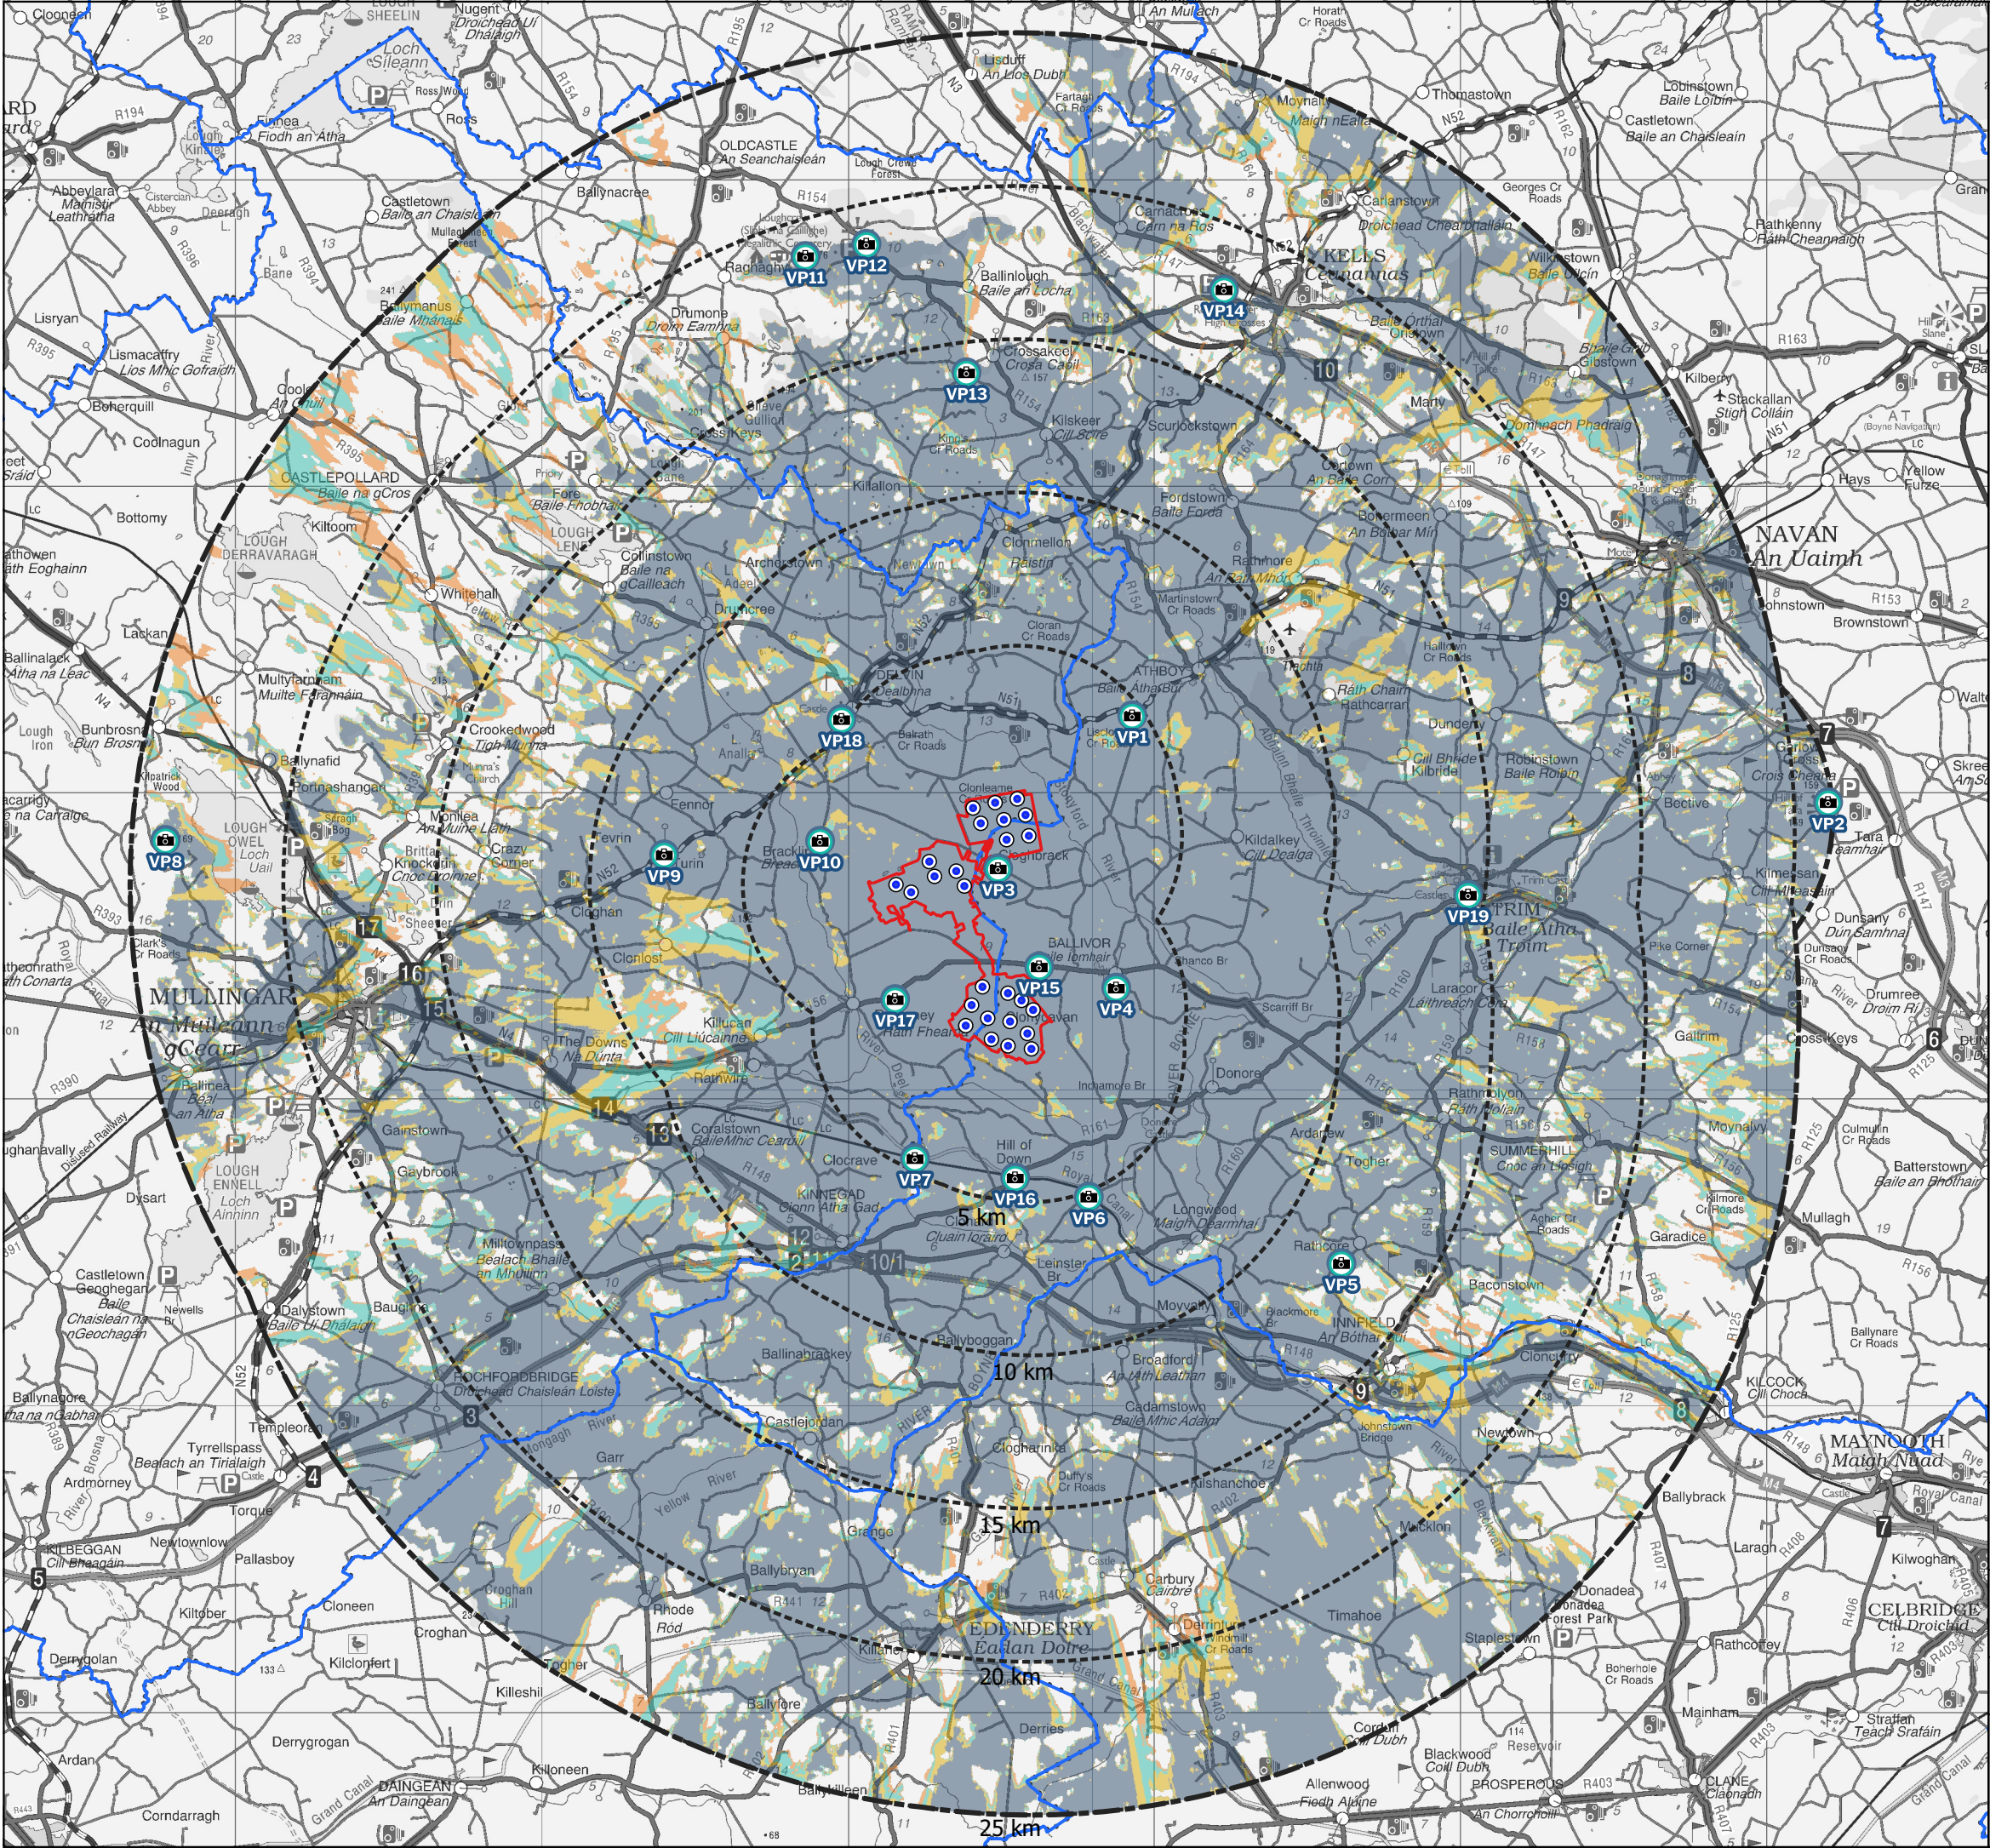
Due to a digital malfunction, the colours of the Zone of Theoretical Visibility (ZTV) were absent in the ZTV map – Figure 13-1 of the EIAR which is reinserted below. The Applicant has reproduced this map below with the ZTV colours included.

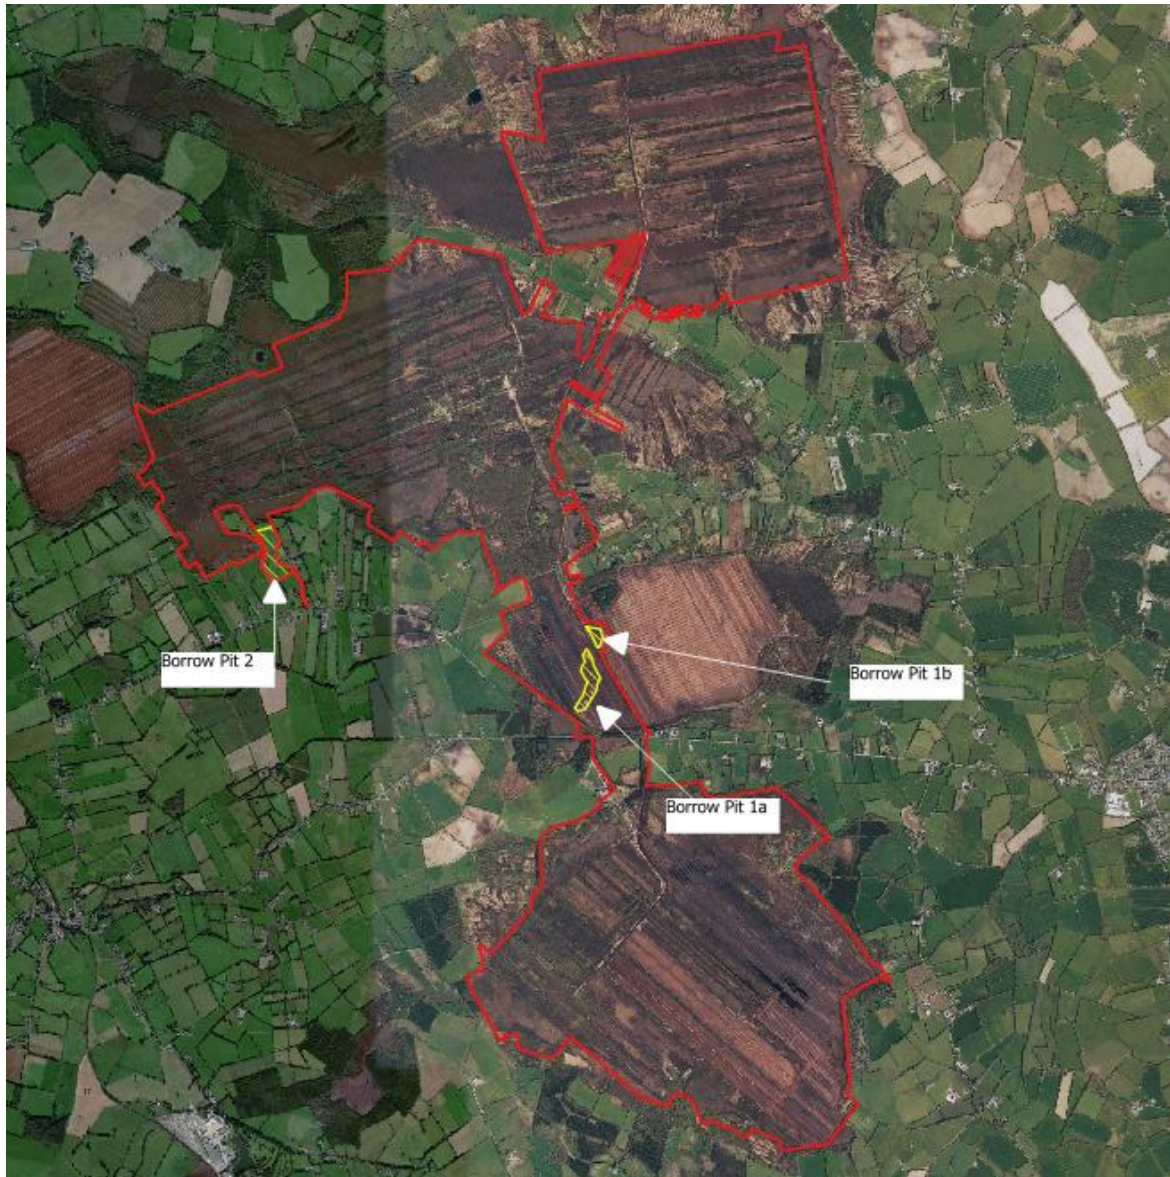
Figure 8. Borrow Pit Locations

The reference / numbering convention included in the EIAR is correct. The error is only included on the planning drawings (Drawing 191137-67, 191137-68 and 191137-69) and Appendix 8-1 of the EIAR. For clarity the table below outlines the name and location of each borrow pit and are illustrated in Figure 6 below.

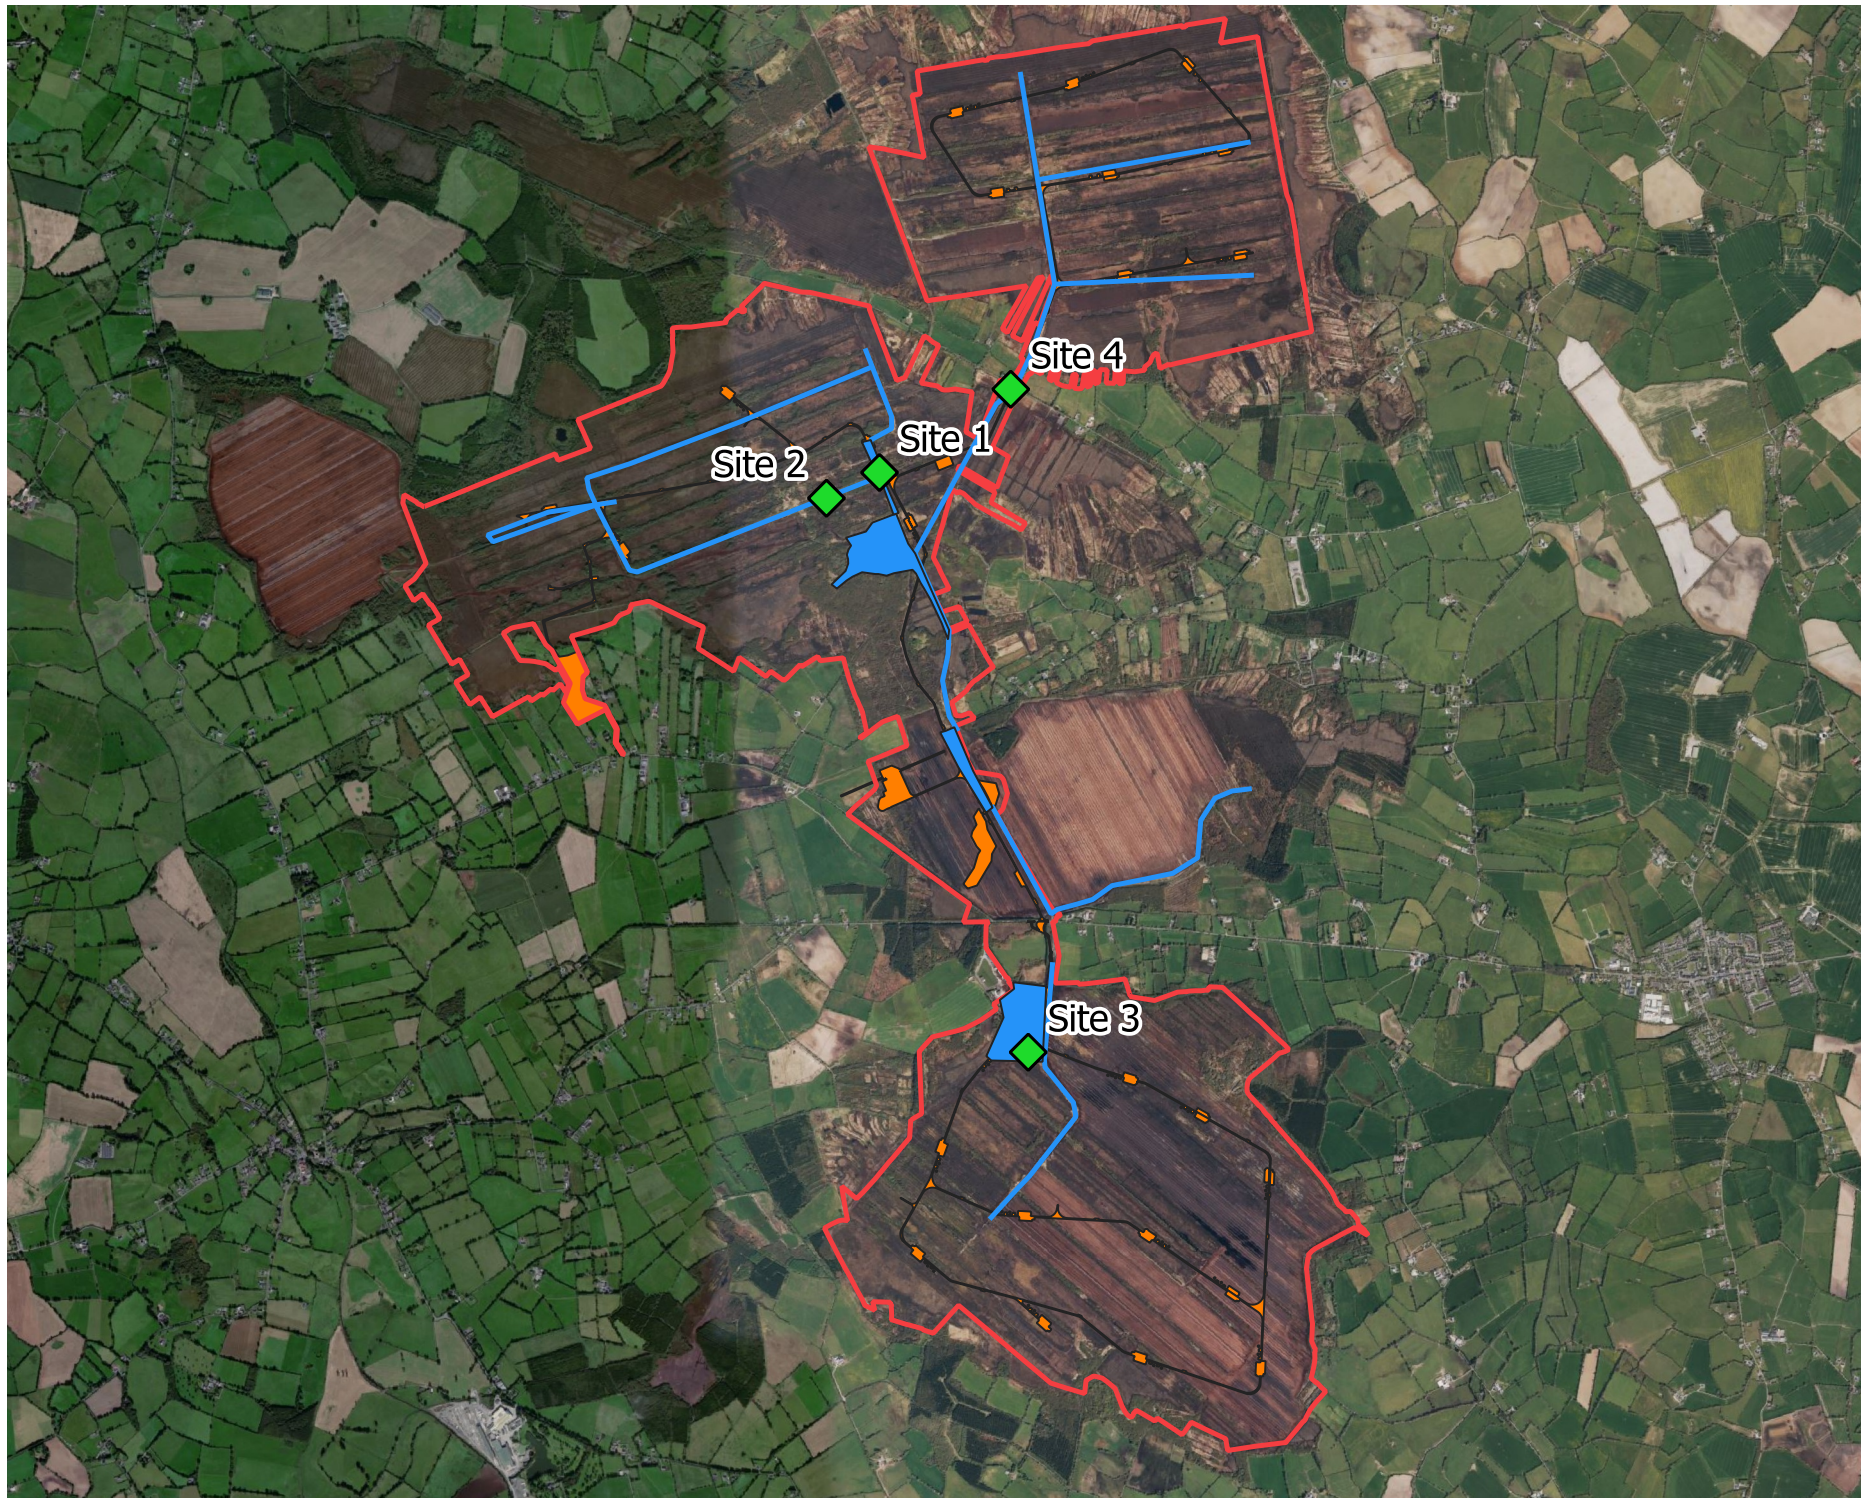
Drawn By	PD	Checked By	PR
Project No.	191137-o	Drawing No.	Figure 2-2
Scale	1:47,000	Date	25/08/2023

These surveys, like previous years, followed the methodology described in the NRA (2009) best practice guidance document. Additionally, the NBDC methodology entitled *Habitat Condition Assessment For Marsh Fritillary* was also followed. The 2023 survey effort is shown in Figure 2-2.

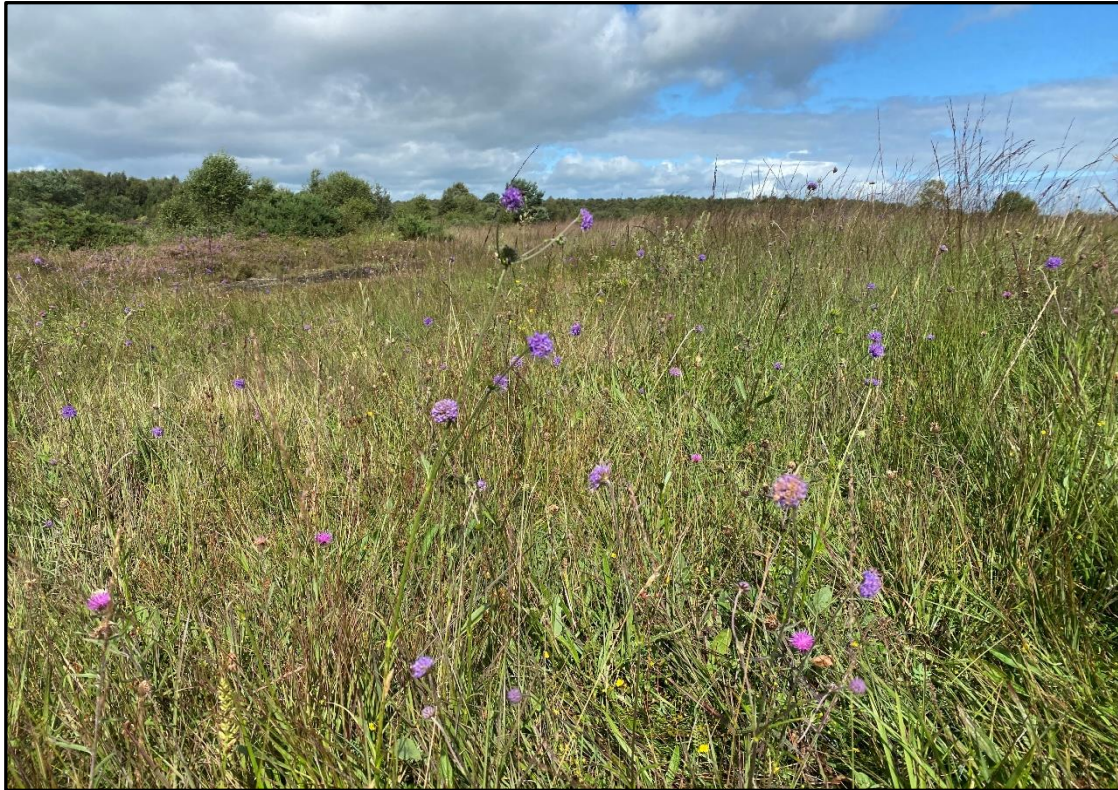
Plate 3-1 Suitable marsh fritillary habitat identified adjacent to existing railway infrastructure between proposed Turbines 13 & 14. This is in the vicinity of Site 1 of the DRB Community CLG Lepidoptera report.

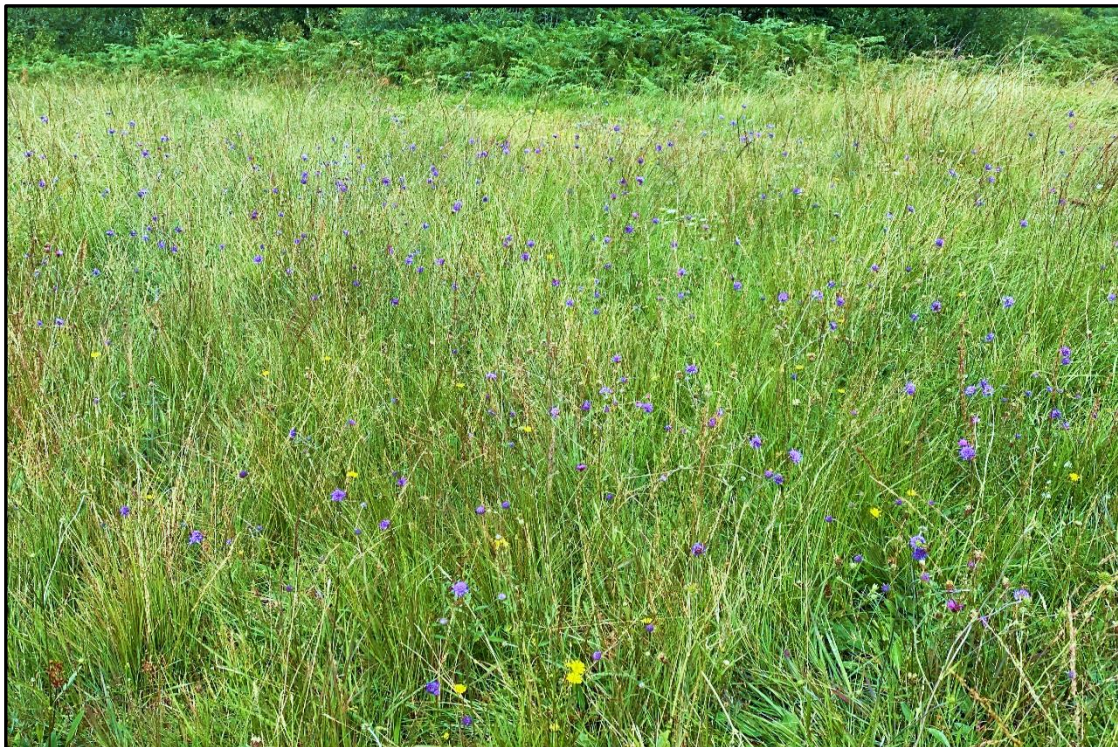
Plate 3-2 Suitable marsh fritillary habitat identified in a semi-natural grassland habitat adjacent to existing railway, approximately 200m south of Plate 3-1

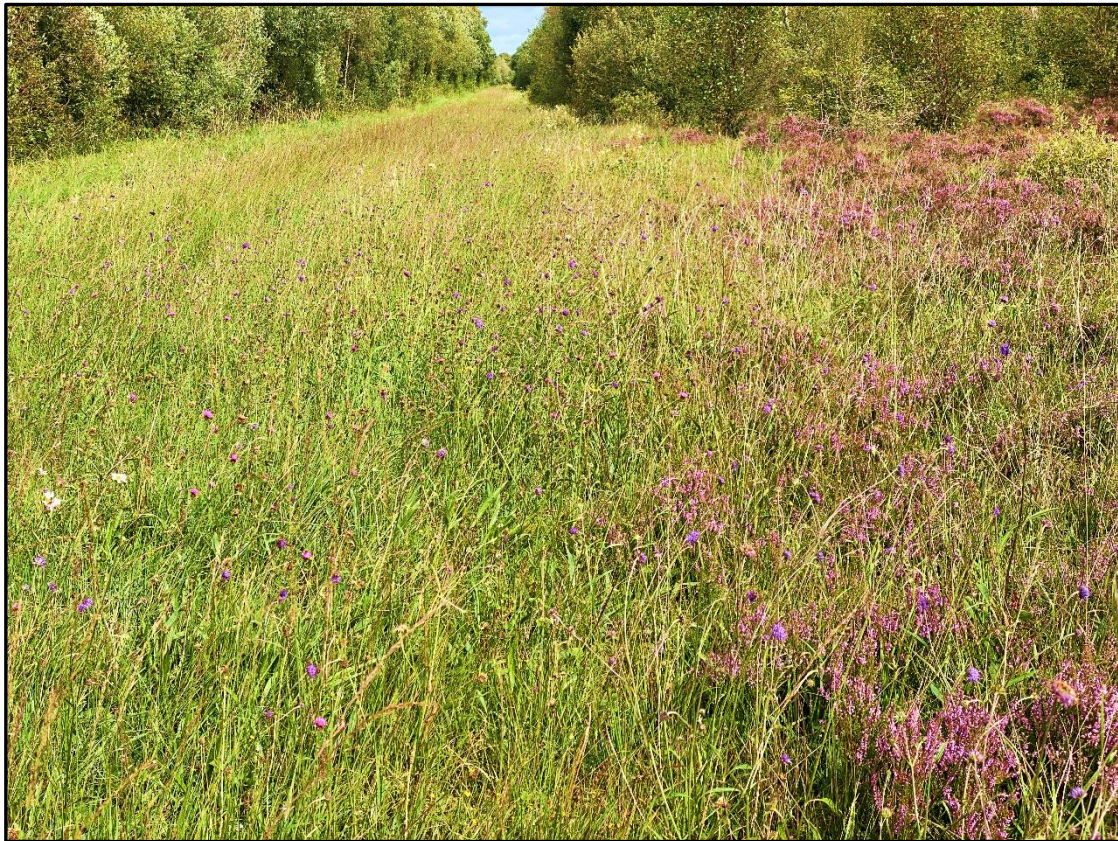
Plate 3-3 Suitable marsh fritillary habitat identified adjacent to existing railway infrastructure southwest of Turbine 14, in the vicinity of Site 2 of the DRB Community CLG Lepidoptera report.

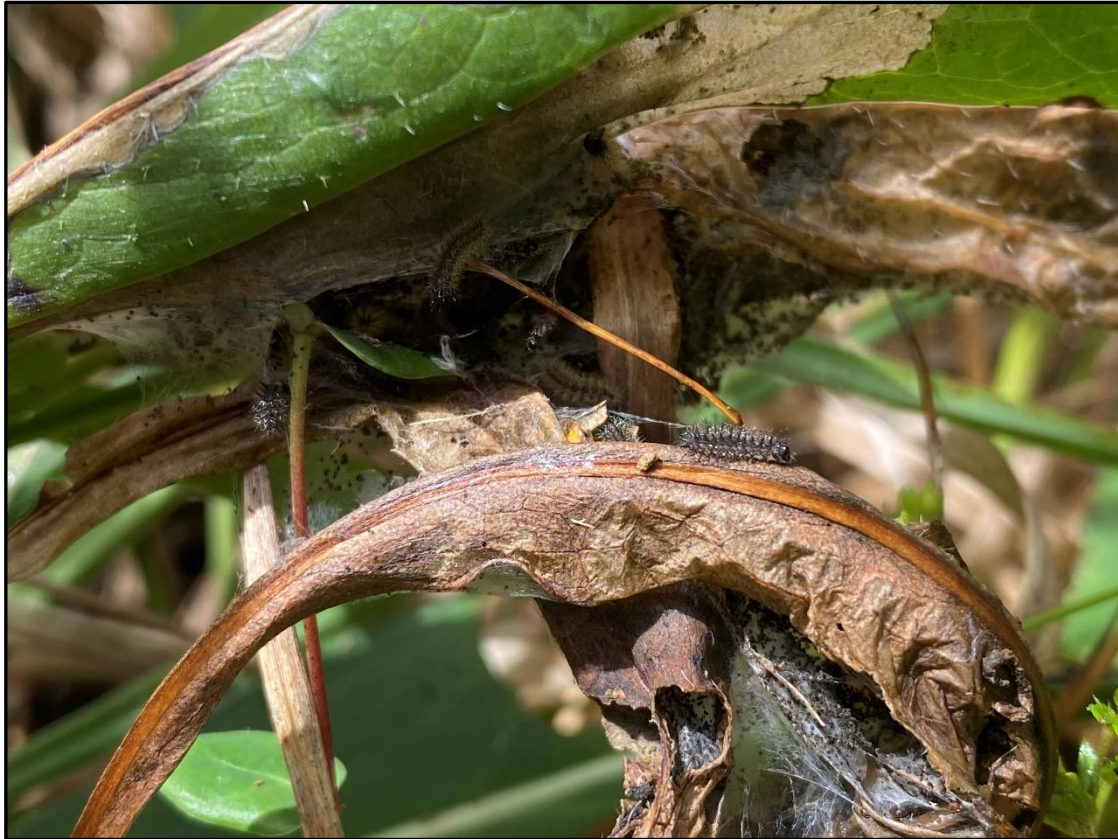
Plate 3-4 Marsh fritillary larval web recorded at IG N63629 57298, approximately 30m west of proposed road infrastructure and adjacent to Site 1 of the DRB Community CLG Lepidoptera report.

Three marsh fritillary larval webs were recorded within an area identified as providing suitable habitat during the 2023 survey effort and are shown in Plates 3-4 to 3-6. This area is located between proposed Turbines 13 and 14 in the vicinity of Site 1 of the DRB Community CLG Lepidoptera report. The locations of the larval webs are shown in Figure 3-1. All larval webs recorded were outside the footprint of the Proposed Development.

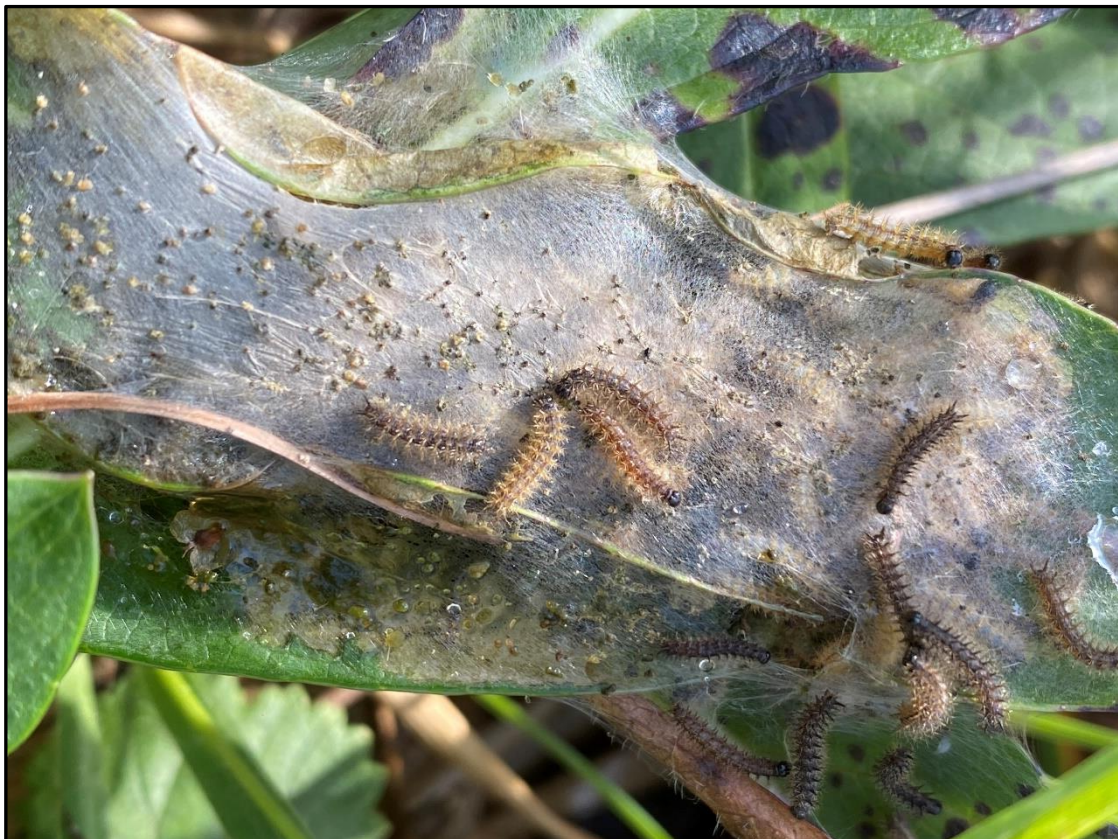
Plate 3-5 Marsh fritillary larval web recorded at IG N63621 57275, recorded approximately 5m south of the web depicted in Plate 3-4.
