Response to Observations Received

Ballivor Wind Farm (ABP
Ref. 316212)

Document Title: **Response to Observations Received**

Prepared By: **MKO
Tuam Road
Galway
Ireland
H91 VW84**

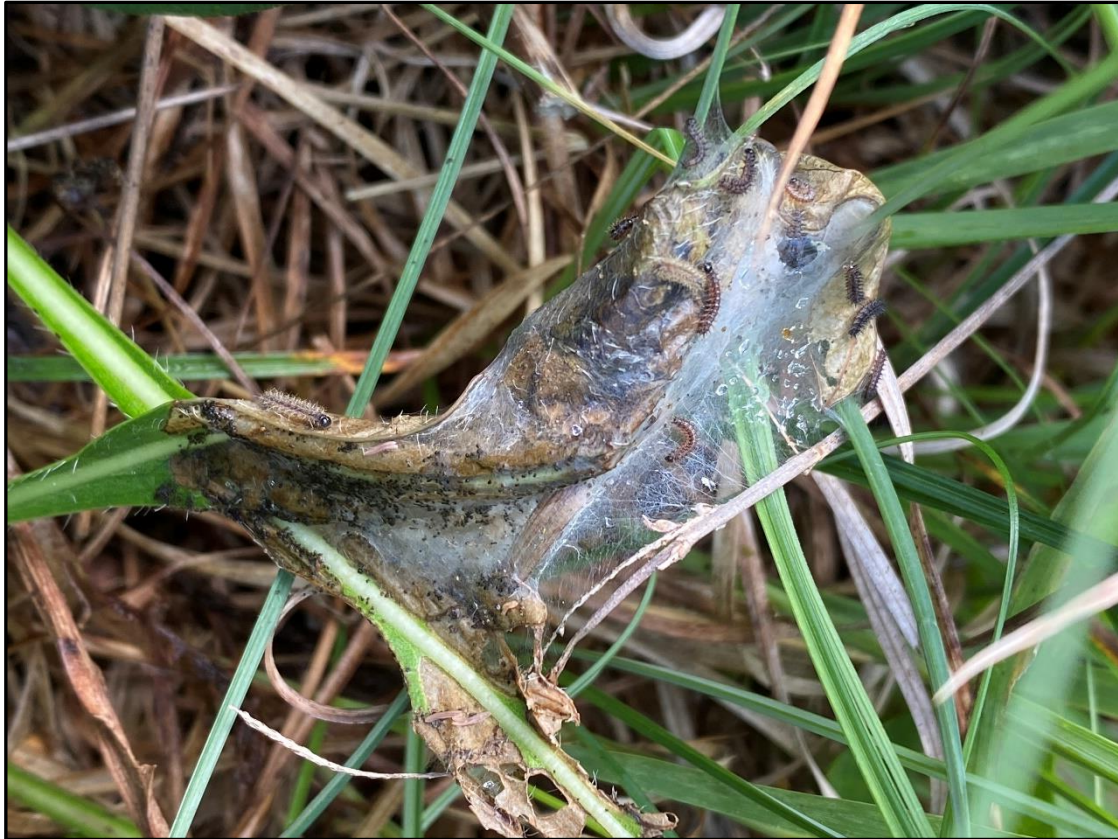
Plate 3-6 Marsh fritillary larval web recorded at IG N63619 57279, approximately 10m west of proposed road infrastructure and 15m north of Site 1 of the DRB Community CLG Lepidoptera report.

Three marsh fritillary larval webs were recorded within an area identified as providing suitable habitat during the 2023 survey effort and are shown in Plates 3-4 to 3-6. This area is located between proposed Turbines 13 and 14 in the vicinity of Site 1 of the DRB Community CLG Lepidoptera report. The locations of the larval webs are shown in Figure 3-1. All larval webs recorded were outside the footprint of the Proposed Development.
